415 West Washington Historic Structure Assessment

415 West Washington, Ann Arbor, MI 48103

Final Report August 29, 2013

RUETER ASSOCIATES
ARCHITECTS

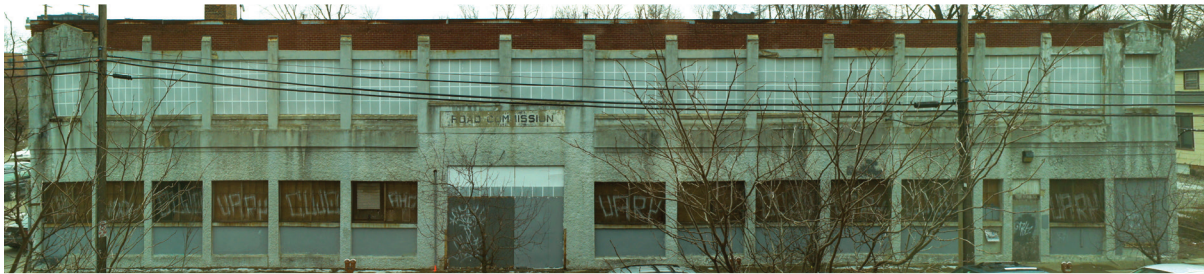
North facade facing Washington street in 2013 (photo is a distortion corrected panorama).

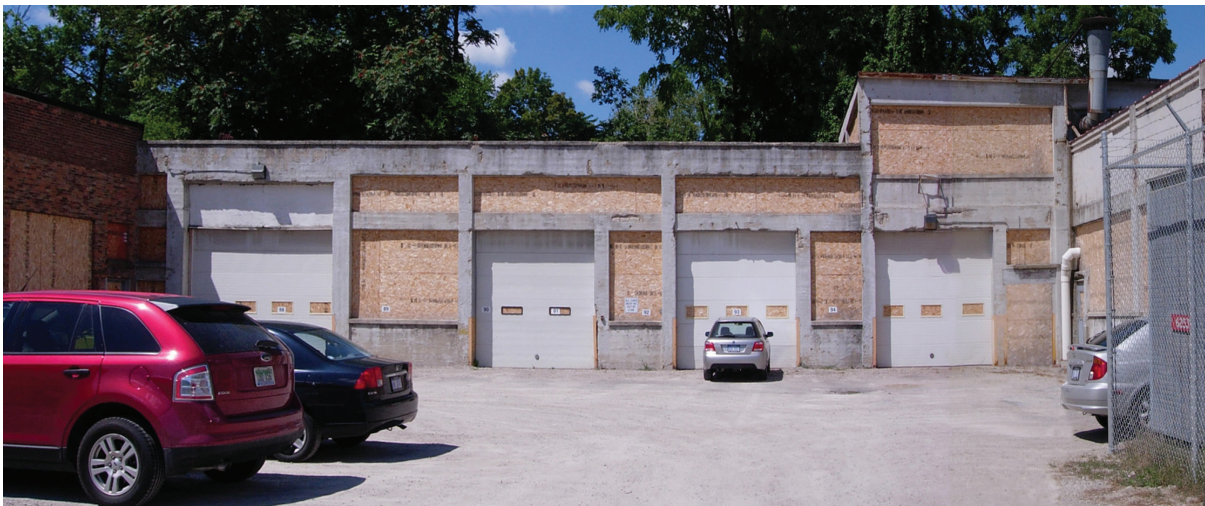
2012 photo of the 1928 addition showing the steel sash covered with OSB board for security.

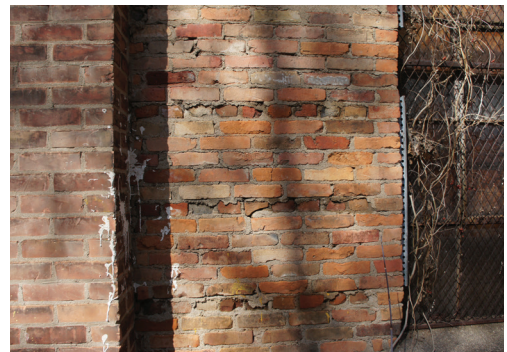
Rear of CWA brick garage. The reclaimed brick masonry on the wall to the right is very poorly laid. The bond courses are recessed and do not match the plane of the face layers. Joints vary greatly in width and are not struck. Note the contrast on the left where the pilaster is of new harder brick with flush struck joints and even coursing.

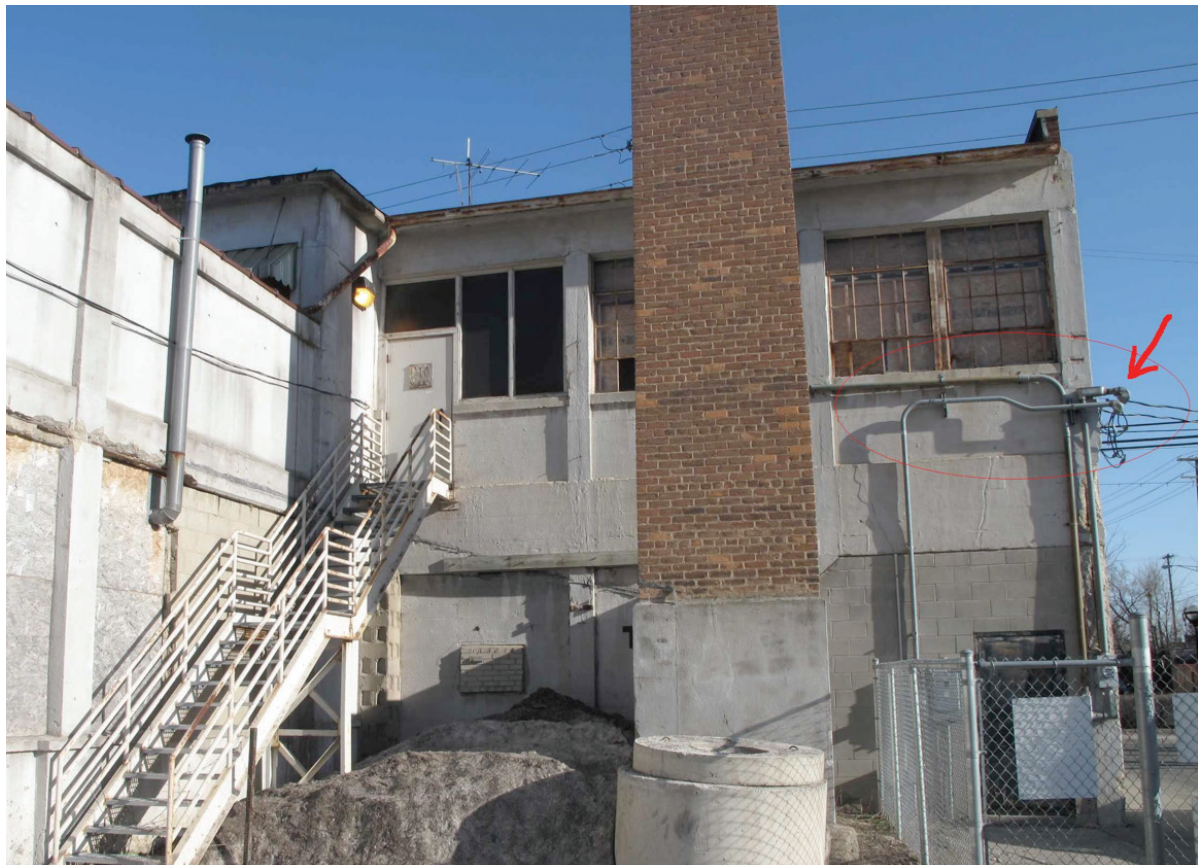
Picture E1: Existing electrical service at corner of buildings A & B

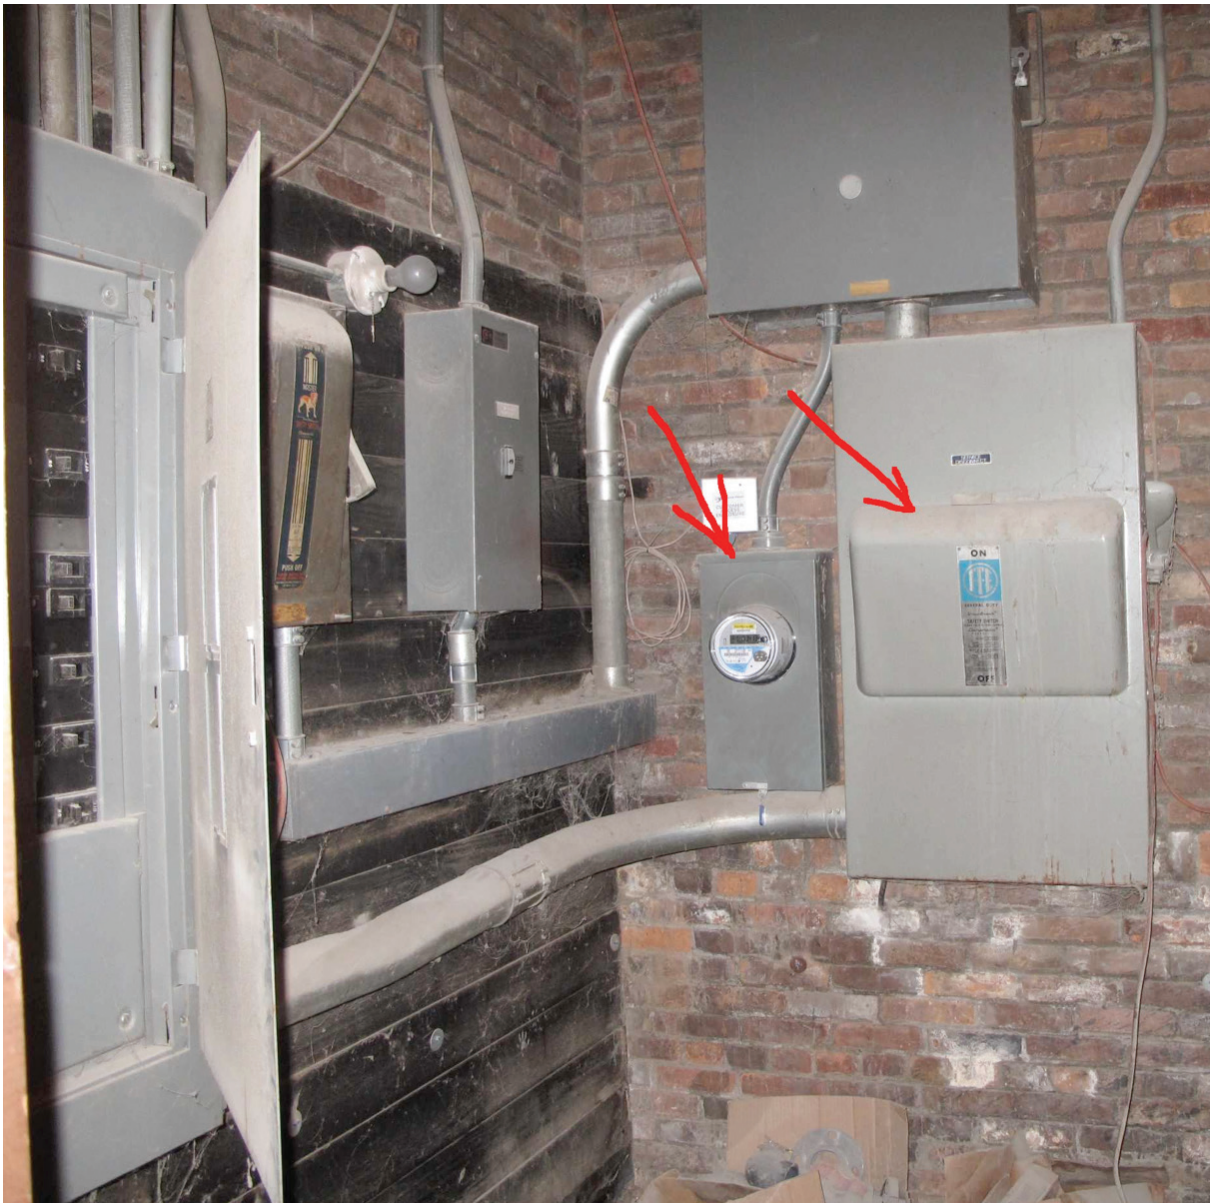
Picture E2: Existing electrical service at building D

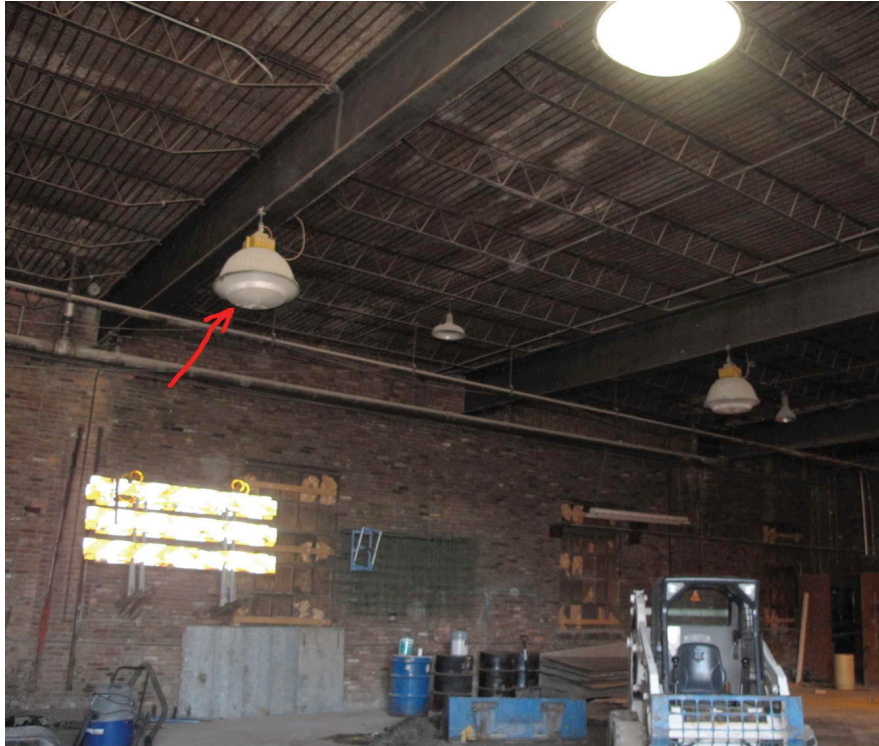
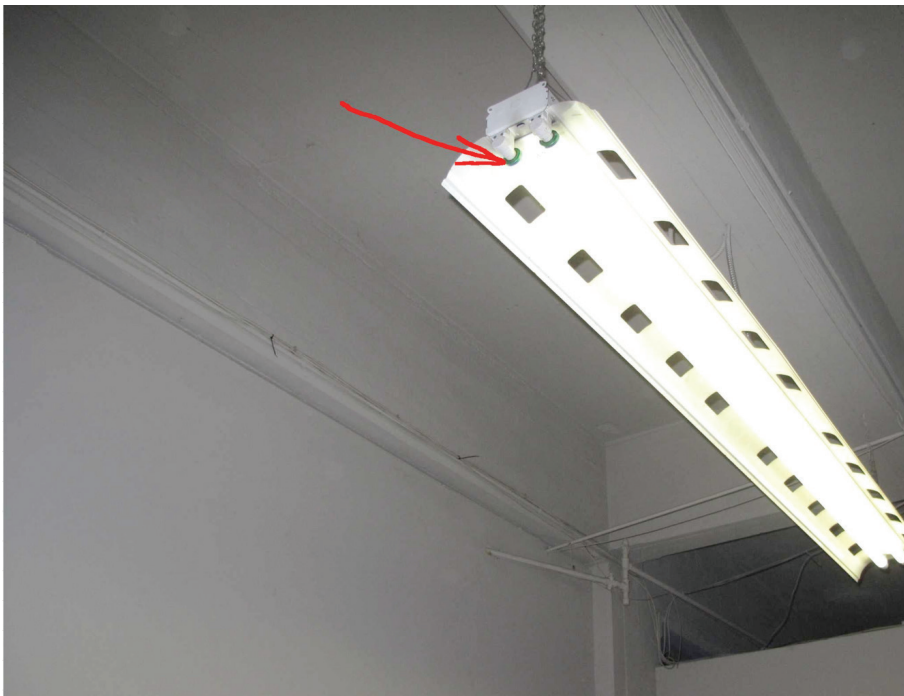
Picture E3: Existing lighting
Condition Evaluation

Picture E3: Existing lighting

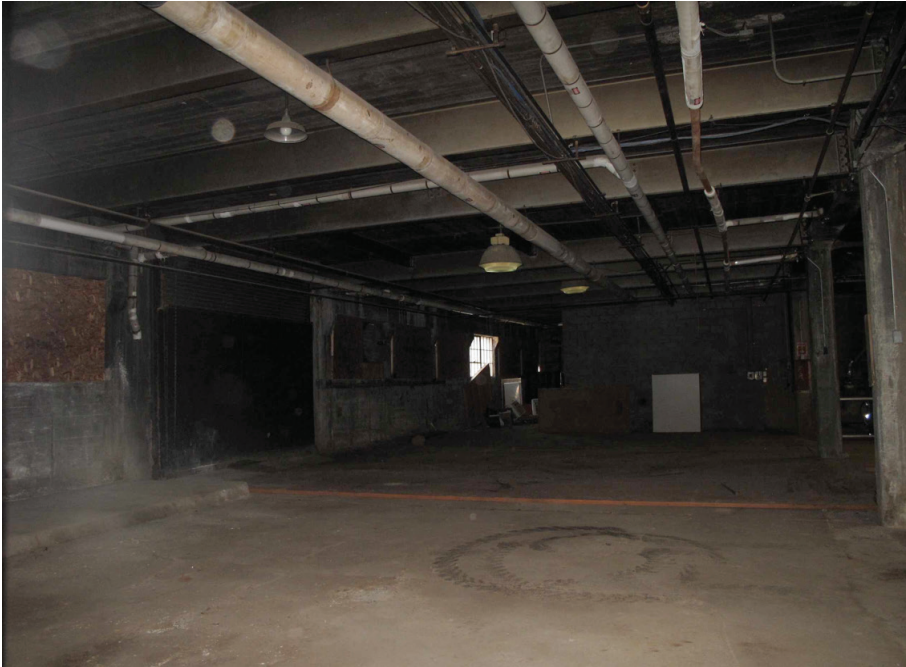
Picture M2: Existing piping to be demolished
