FOURTH & WASHINGTON PARKING STRUCTURE

MAINTENANCE REVIEW - 2008

Carl Walker, Inc. Project No. R1-2008-246

CITY OF ANN ARBOR DDA

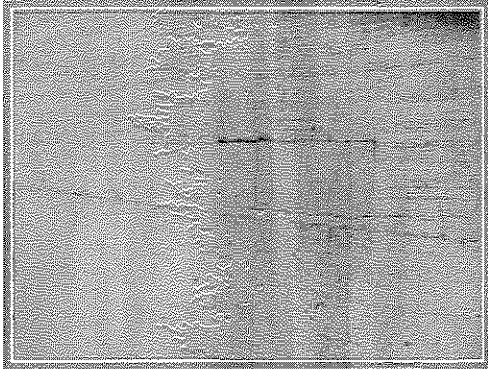
C1 - Topping Delaminations: A few delaminations were noted in the precast topping. The delaminations were small in size ranging from 1 square foot up to 10 square feet. Some of the delaminations noted were previous patches that have failed. The top of slab delaminations should be repaired to prevent further deterioration.

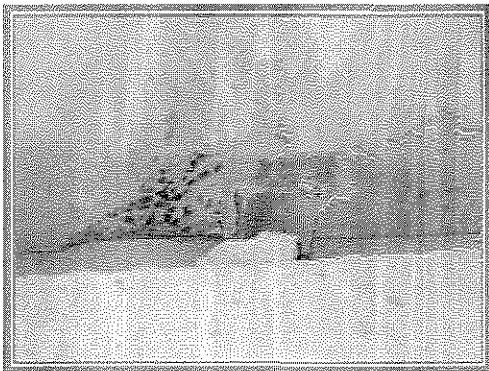
C2 - Ceiling Delaminations: Approximately 20 square feet of ceiling delaminations were noted at random locations throughout the structure. All loose concrete should be removed to prevent it from falling on pedestrians or vehicles, and the concrete should be patched back to the original surface.

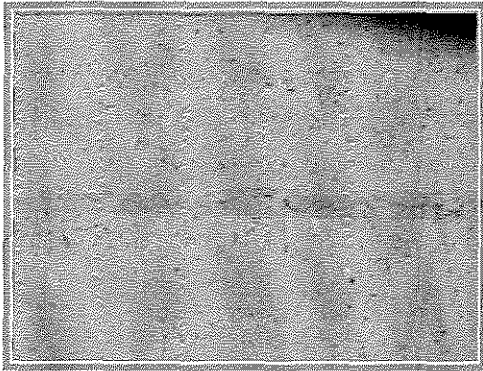
W1 – Joint Sealants: All of the joint sealants on the Roof Level (Level 7) are showing signs of deterioration due to UV exposure. Joint sealant failure was noted at random locations throughout the rest of the structure. We recommend replacing all joint sealants on the Roof Level and repairing failed sealants at all other levels to protect the structural members from deterioration caused by moisture and chlorides.

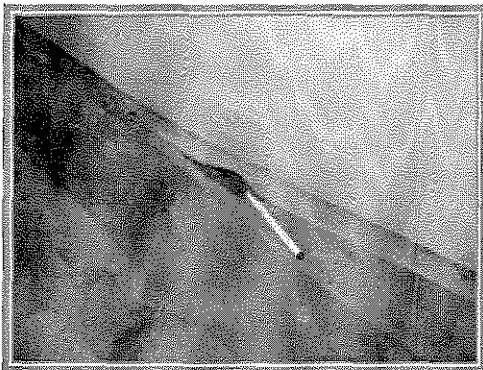
W2 – Cove Sealants: All of the cove sealants at the roof level are showing signs of deterioration due to UV exposure. Cove sealant failure was noted at a few random locations throughout the rest of the structure. We recommend replacing all of the cove sealants on the roof level and repairing all failed cove sealants to protect against moisture and chloride related deterioration.

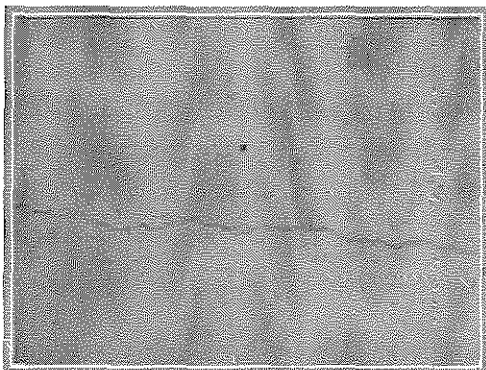
W3 – Rout and Seal Cracks: Cracks were noted at random locations throughout the structure. Cracks allow moisture and chlorides to easily penetrate the concrete. The cracks should be routed and sealed.

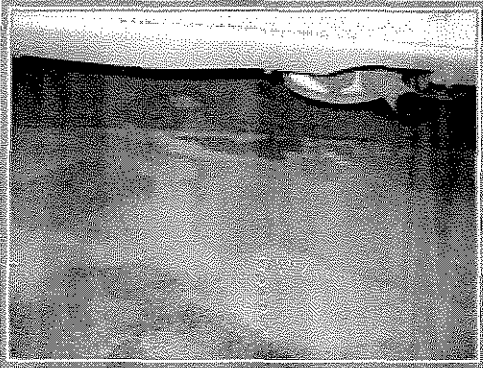
W5 – Deck Coating Repair: A small amount of deck coating failures were noted at Levels 2 and 7. Deck coating failure consists of areas where the deck coating has debonded from the concrete or the base membrane has been damaged. A full deck coating system should be applied at these locations.

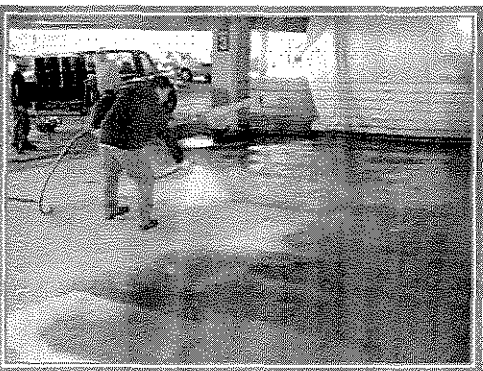
W7 – Sealer: A silane sealer was applied to all supported concrete areas during original construction in 1999 and then in 2007. Silane sealers help to reduce water and chloride intrusion into the concrete that may lead to corrosion of the embedded reinforcing steel and embedded connector plate steel over time.

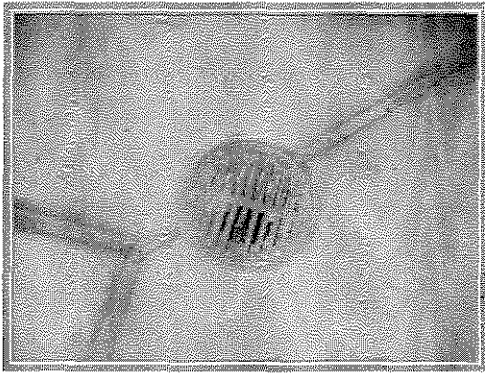
ME1 – Broken Floor Drain Grates: Floor drain grates throughout the structure appear to be in good condition. One broken floor drain grate was noted on Level 2. The broken grate creates a potential trip hazard and should be replaced.

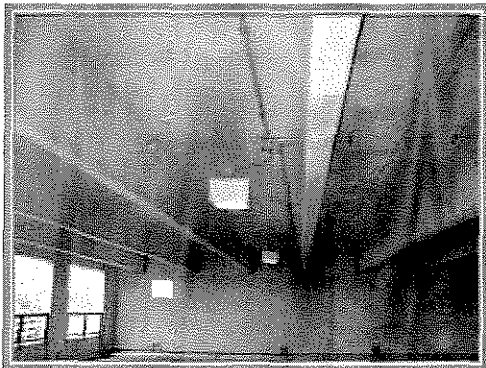
E1 – Lighting: The lighting system consists of 175W metal halide light fixtures. The light levels at the below grade levels appeared to be low during our review. There have been significant advancements in fluorescent lighting recently which provide energy efficient lighting. We recommend upgrading the lights to provide improved light levels and energy efficiency.

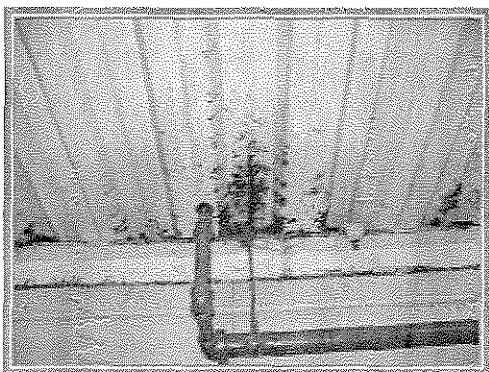
M1 – Clean & Paint Steel (at South Stair): As stated in Item W6, corrosion was noted on the steel in the South Stair. Corrosion was also noted on the handrails in the South Stair. In addition to deck coating the South Stair, as recommended in Item W6, we recommend cleaning the steel to remove corrosion and repainting the underside to protect against further corrosion. The handrails should also be repainted.

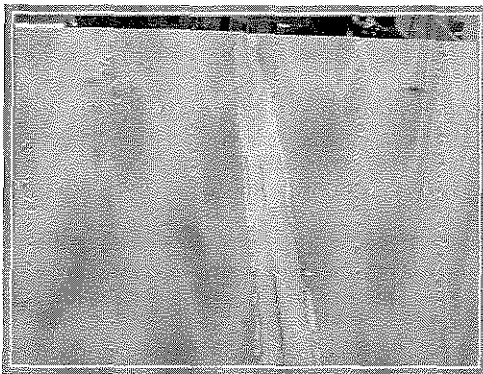
W3 – Flashing Sealant: At the exposed perimeter walls of portions of Levels 6 and 7, there is a metal flashing that covers the top of the wall. This flashing protects the opening between the concrete spandrel wall and the brick façade. Each butt joint sealant along the entire length has failed. These joints should be replaced with a UV stable sealant to maintain the integrity of the flashing system and to prevent damage to the structures façade components.

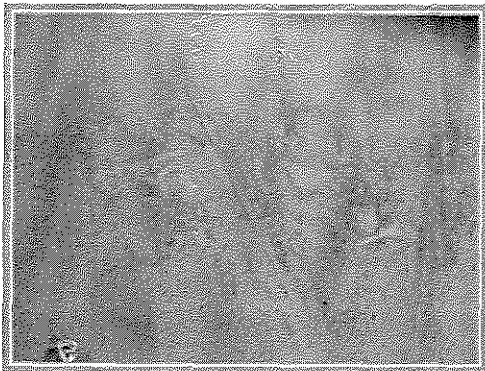
W5 – Deck Coating: All supported slab areas are deck coated. Overall, the deck coating is performing well. There was one location on Level 2 in a high traffic area that is showing wear, totaling around 220 square feet. This area should be recoated to maintain the integrity of the waterproofing system. A portion of this worn area is located above the lower level occupied space and could lead to future problems if not repaired soon.

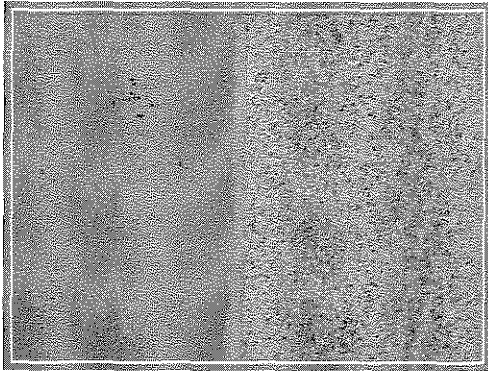
W6 – Epoxy Coatings: Portions of the supported slabs appear to have been recently coated with an epoxy and aggregate coating system. These areas are typically located in drive lanes that previously shown some wear. This system appears to have been applied well and should resist wear better than the existing urethane coating.

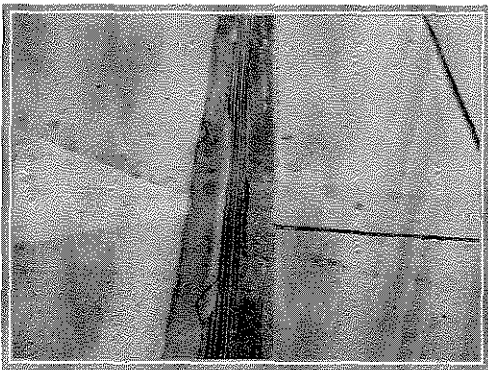
W7 – Expansion Joint – Strip Seal: The expansion joint at the entrance ramp has failed at the nosing material. Although there is no occupied space below this area where leaking would be a concern, we recommend replacing this joint at this time. As this is a high traffic area and this type of expansion joint has failed over time like the original joint we would recommend that a reinforced nosing bolt down expansion joint be installed at this time. This will require some concrete work to create a deeper blockout for this new joint.

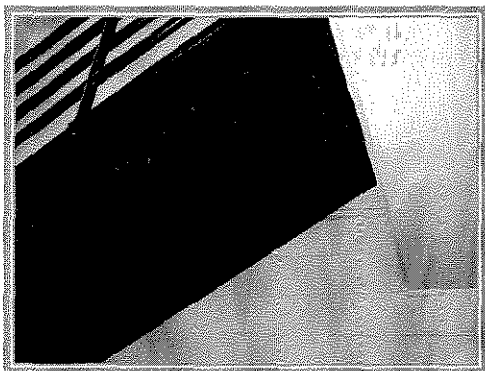
M1 – Stair Repair & Paint Touchup: Water has been an ongoing problem for both the north and south stair in this structure. Leaking into the concrete treads and landings has caused wide spread corrosion of the steel framing members. In some cases, 100% section loss of the steel framing was noted. Any members that are replaced or cleaned of corrosion should be repainted to match the existing framing.

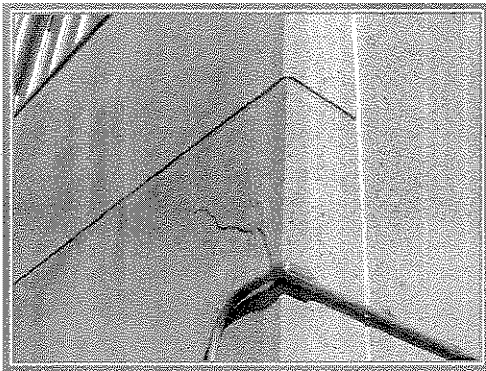
C2 – Wall Delaminations: In isolated locations of the structure small concrete wall delaminations were noted. These few delaminations do not appear to be caused by chloride induced corrosion and are simply cosmetic. Repairing these spalls is recommended to protect any exposed steel reinforcement that may be present.

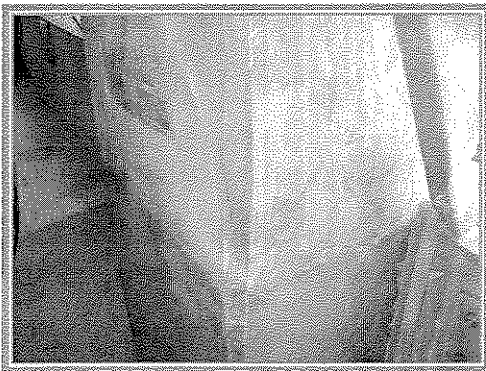
C3 – Column Delaminations: Columns and shear walls throughout the structure are in good shape overall. A majority of the column delaminations are located on Level 4 and consist mostly of failed patches. These locations should be repaired to prevent damage to the structural steel reinforcement in the columns.

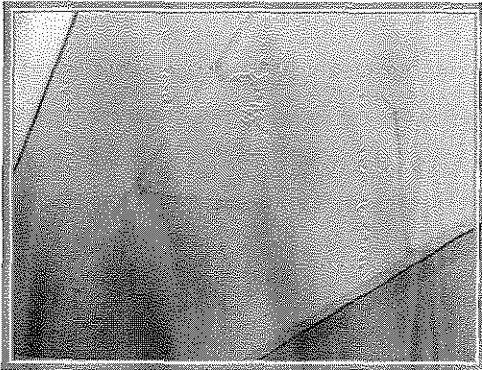
W1 – Joint Sealants: Throughout the structure, a large amount of joint sealants were noted that are in need of repair. The total amount of deterioration includes approximately 6,000 linear feet. At many locations, leaking is occurring causing staining of the ceiling below. The sealants are original to the structure, which was constructed in 2001 and are getting close to their estimated service life of 8 years. A majority of the failed sealants are located at the exposed roof level, where the harsh environment tends to take a heavier toll on urethane materials. Joint sealants should be replaced to prevent leaking and damage to the precast tees.

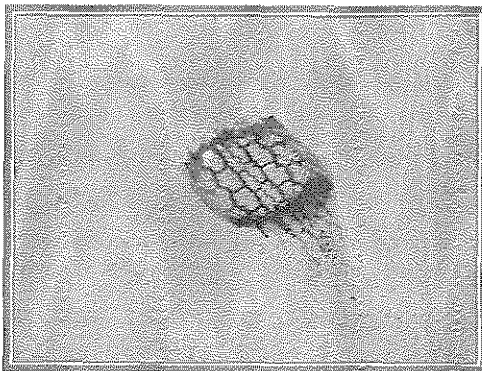
W3 – Deck Coating: Throughout the structure there are existing deck coatings at the exposed roof level, beam crossovers and over storage/occupied areas. The coating appears to be in good condition with less than 1,500 square feet of repair needed. These repairs include recoating worn crossovers, and applying a full system at small areas of debonded or damaged coating and areas in need of concrete repairs. Maintaining the membrane system is critical in the long-term durability of the structure.

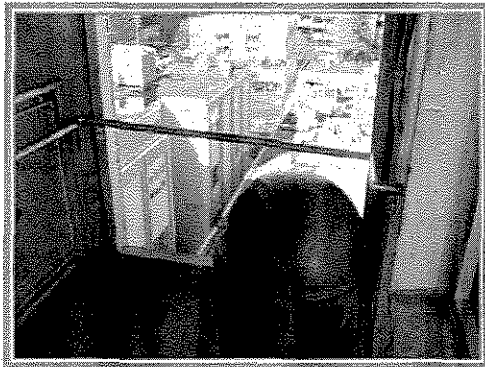
M2 – Handrail Repair: A hand rail in the North stair tower at Level 7 has been rotated out of place. This hand rail should be repaired to prevent possible pedestrian injury. Placement of an additional support at the right hand corner after the pipe railing has been reset will prevent this rotation from reoccurring.

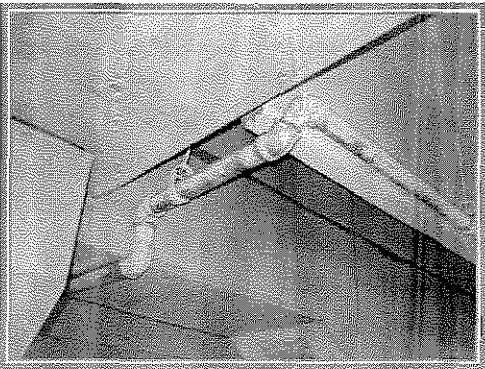
M3 – Mechanical Piping: Minor surface corrosion and peeling paint was noted on the mechanical piping throughout the structure. These areas of deterioration should be cleaned and repainted to help prevent further deterioration and for aesthetics.

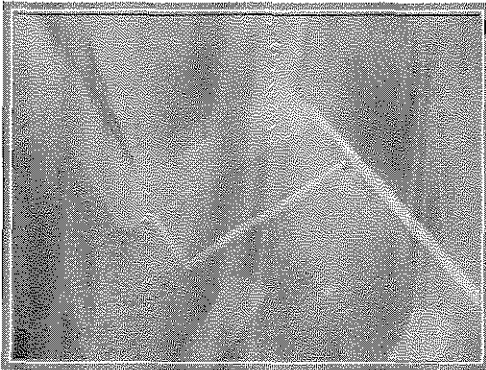
C1 – Topping Delaminations: Areas of the concrete topping were noted to have delaminations due to corrosion of embedded plates. Topping replacement at these areas is recommended. There are some other areas where the topping is debonded at these plates but no real concrete deterioration has occurred. At these locations it is recommended to deckcoat over the areas to prevent moisture from infiltrating leading to steel plate corrosion.

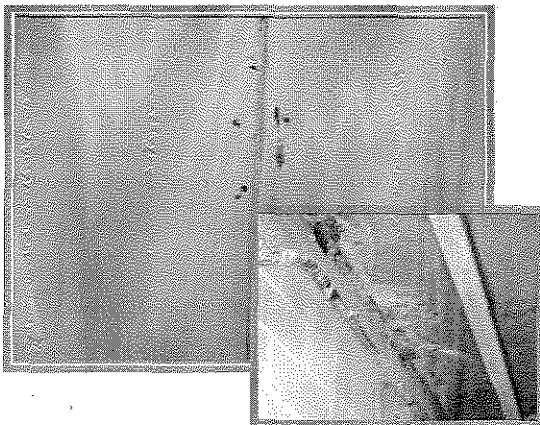
C2 – Precast Tee Flange Delaminations – Ceiling: At various locations throughout the parking structure there is corrosion related concrete deterioration of the tee flange. These locations are primarily at locations where leaks in the sealants above have led to corrosion of embedded steel at these locations and will require repair of the concrete and sealant.

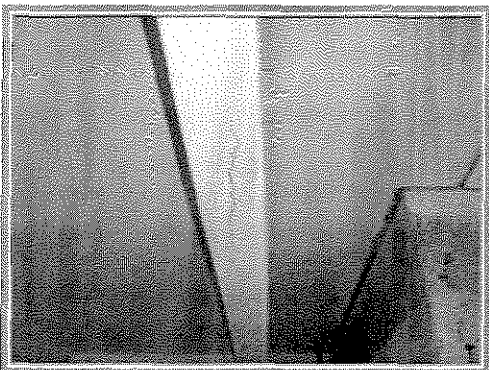
C3 – Precast Tee Stem Delaminations – Ceiling: Various locations throughout the parking structure, most of which is at the grade or below, there are cracks in the tee stems. This may indicate corrosion of the post-tensioning strands. These locations will require concrete repair to maintain the structural integrity of the tee and possibly structural strengthening depending on the damage to the strands.

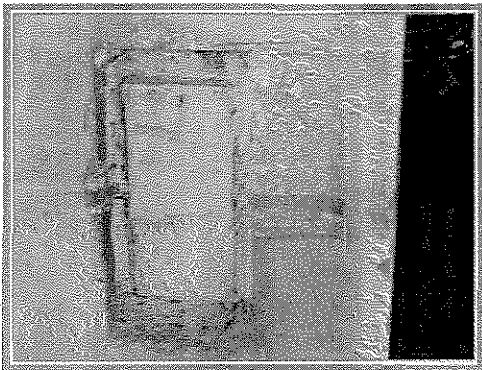
C5 – Wall Delaminations: Several locations throughout the structure where the grout pockets installed over the embedded connector plates for the shear walls has spalled off leaving the plates exposed. In the past, these areas have been painted for protection from corrosion. We recommend painting these plates and patching the concrete cover back with mechanical connection to prevent future spalling.

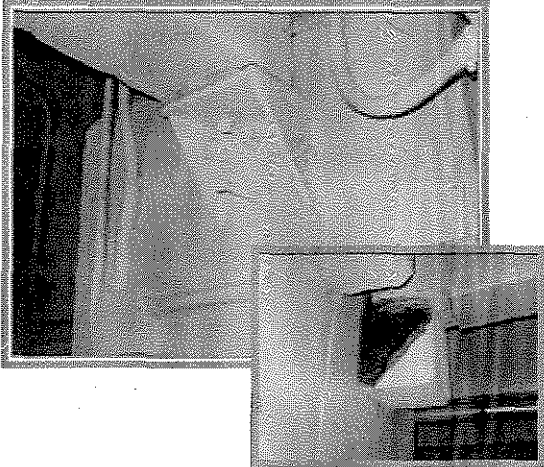
C8 – Haunch Repairs: At the below grade levels of the structure there is continued deterioration of concrete/steel haunches on the foundation wall that supports the double tees. The concrete cover is fire protection for the steel supports. Some of these were repaired in 1998. Additional deterioration was noted and requires repair.

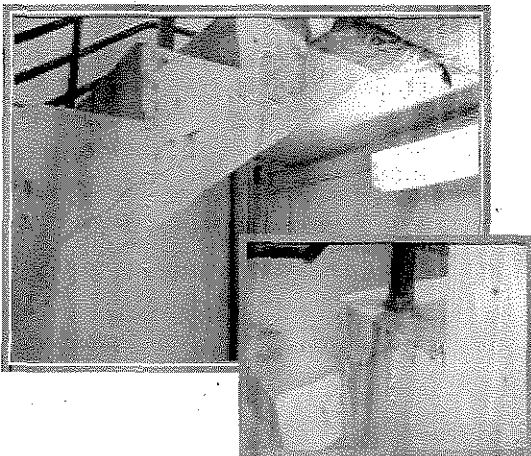
C9 – Concrete Stair Delaminations: Large concrete delaminations at the east stair tower were noted during our review. These delaminations include the underside of the stair, primarily at or below grade. Other areas of deterioration were noted at handrail supports where they are embedded in the concrete. Repairs to the concrete stairs should be considered a priority.

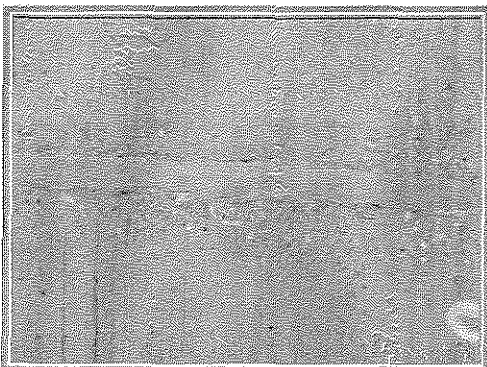
W1 – Joint Sealants: The Roof Level sealants are showing signs of weather checking and bond failure. These sealants were replaced in 1998 and spot repaired over the years. Joint sealants at other levels throughout the parking structure had failures at random locations. The sealants at the Ann Ashley parking are 10 years old and are considered to be at the end of their useful life.

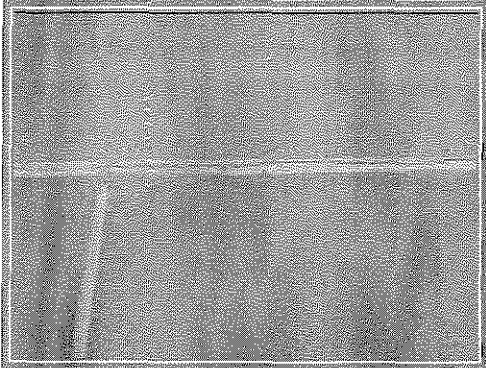
W2 – Cove Sealants: Cove sealants at the Roof Level appear to have plow damage. These sealants should have spot repairs completed or a full replacement completed at the same time as the joint sealants.

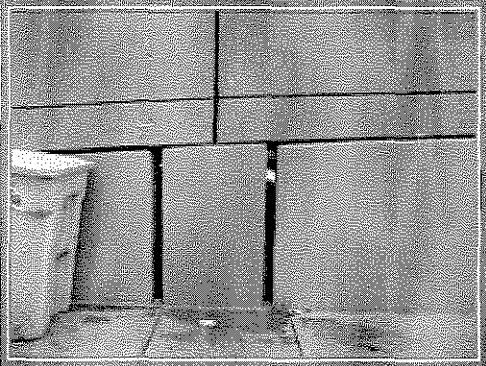
W3 – Rout & Seal Cracks: Some random cracks in the topping, walls and columns at the Roof Level were noted. A few cracks were sealed during recent repair, but more exist and should be sealed to prevent water infiltration.

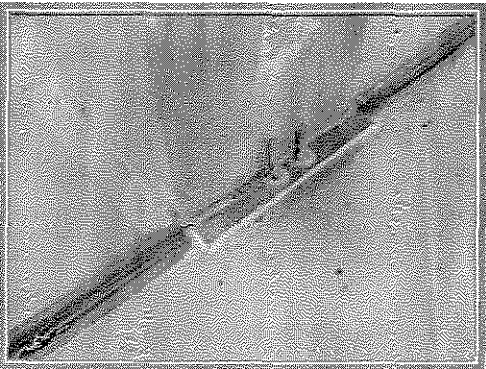
W5 – Expansion Joint: Two types of expansion joints exist in this structure. Ribbon seals (premolded urethane), which are typically located at elevator towers and strip seals (winged expansion joint) typically located where joints are exposed to vehicle traffic. There are several areas where a failure of the nosing materials on both types of joints has occurred. These areas need to be repaired to prevent water infiltration to structural elements below.

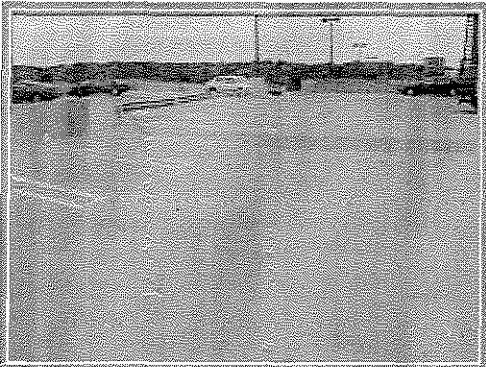
W6 – Roof Level Deck Coating Topcoat: The Roof Level deck coating system is in fair condition. Crossovers were recoated recently with an epoxy deck coating. It is recommended to topcoat the remaining deck coated areas at the Roof Level.

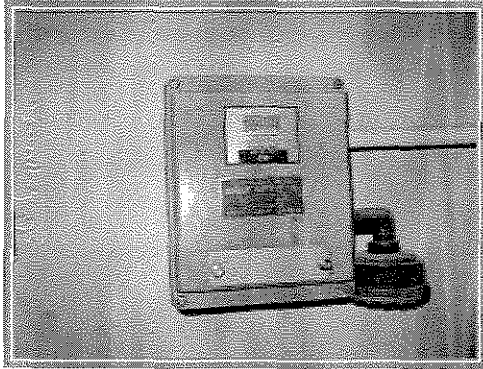
ME3 – CO2 System: The existing carbon monoxide detection system does not appear to be functioning at this time. There is only one unit located at the lowest area of Level B. This unit should be updated with a newer system and integrated with the existing fan system. Newer systems allow remote monitoring of the system via a computer and software.

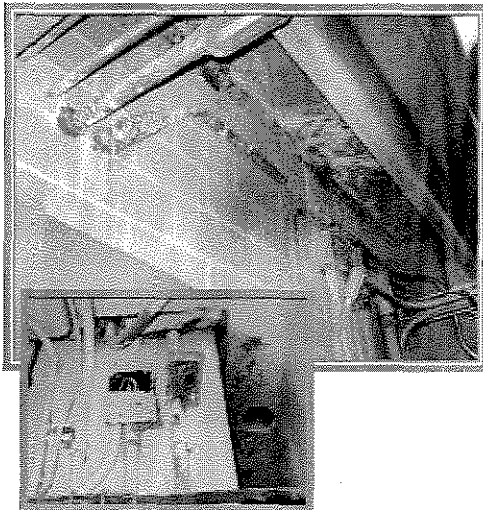
E1 – Conduits: Electrical conduits located at random locations throughout the parking structure have corroded. Also noted were open and corroded junction boxes with exposed wires. Both of the conditions noted above were caused by failed sealants at the level above, allowing water and salt through to the conduits, causing corrosion. To keep the electrical system in good repair, these sections of conduit should be repaired as part of a comprehensive repair program.

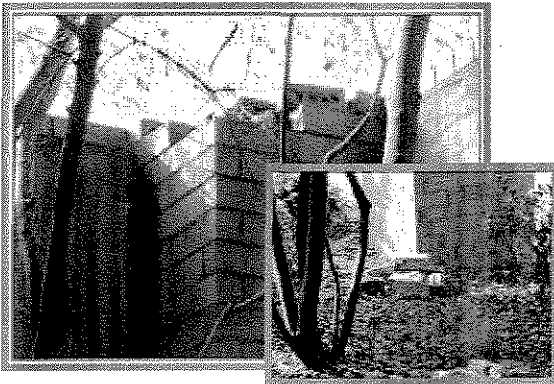
M4 – Brick Repair: Several bricks at Column A/17 at the northeast corner of the parking structure have fallen from the top of the column. Brick in this area should be repaired as part of a comprehensive repair project. These bricks are a fall hazard to pedestrians.

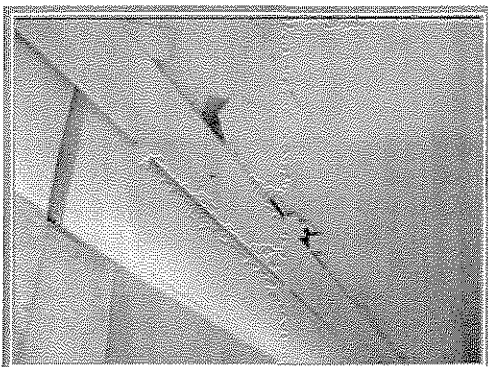
M6 –Shim Plates at Expansion Joints: There are several locations along the expansion joint where the plastic shims are loose and have moved outward. These shim plates need to be reset and perhaps affixed to the appropriate surfaces with epoxy.

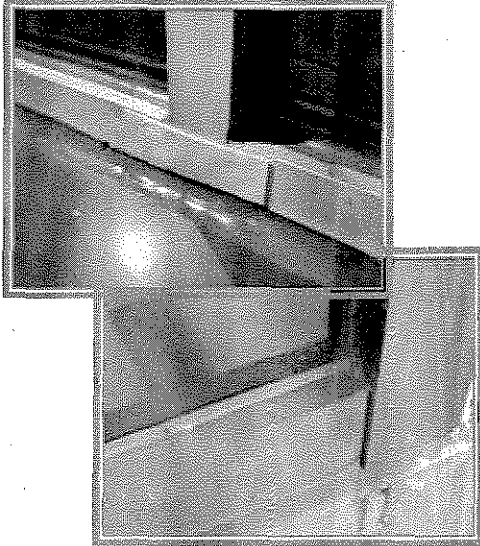
M7 – Mullion Sealant: We observed open metal-to-metal joints at mullion joinery. We recommend installation of new sealant at these locations with silicone bridge sealant or 123 tape (shown in far left photo) to comprehensively create a barrier against water penetration into the window system.

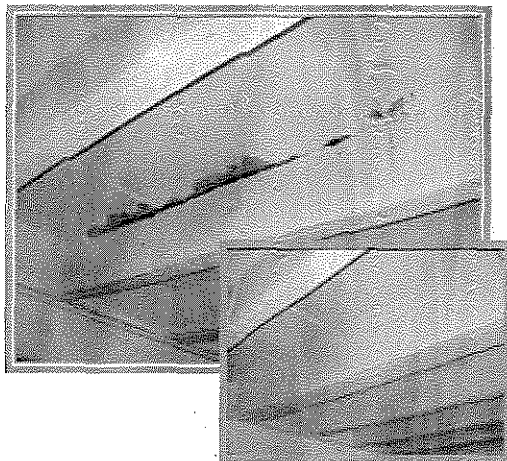
C3 - Slab Jacking: Several areas of slab jacking at the underside of level two were noticed during our walk thru. Slab Jacking is caused by the corrosion of the embedded steel at the top of the joist, forcing the concrete slab to separate or split from the pan joist. Most of the deterioration is located north of grid line 10 as indicated on the review drawings in Appendix E; drawing R1.1. These areas will require full depth removal/replacement of the concrete slab to expose and repair the reinforcement in the joist.

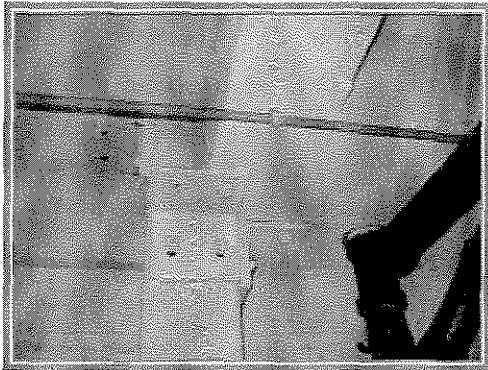
C5 - Beam Delaminations: There were a few locations on the beams with corrosion induced concrete deterioration. Delaminations at or near the bearing areas should be considered a priority repair and can be repaired with conventional patching techniques.

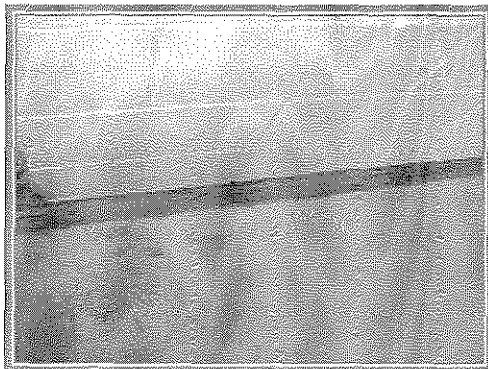
W2 - Rout & Seal Cracks: Cracks in slabs were noted at a few locations at random areas throughout the parking structure. These cracks should be routed and sealed to prevent moisture and chlorides from penetrating through to the embedded reinforcement and structural elements below.

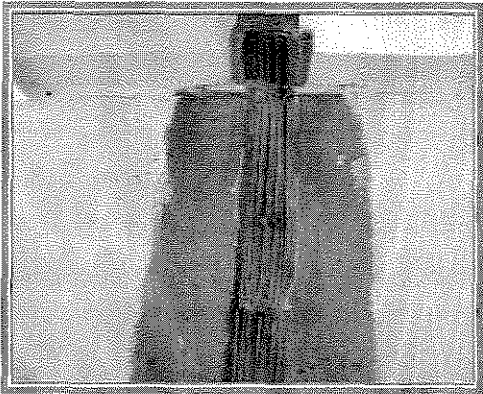
W3 – Expansion Joint Nosing (Strip Seal): Expansion joints throughout the parking structure in general are in good condition. A few of these expansion joints were noted to have damaged nosings. This condition should be repaired to prevent continued deterioration of the nosing.

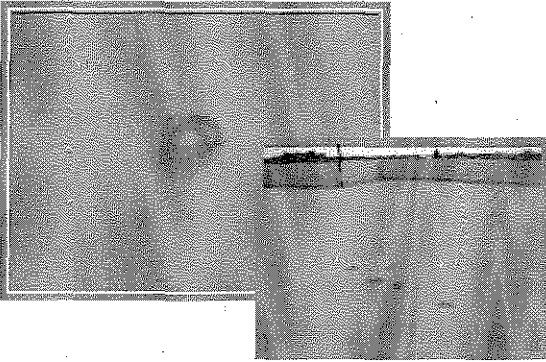
W4 – Expansion Joint Gland (Strip Seal): New expansion joints located at the Roof Level have splices that have failed/separated. These failed splices are allowing water to leak to the level below. This expansion joint is still under warranty, the installing contractor should be contacted to perform repairs to this joint.

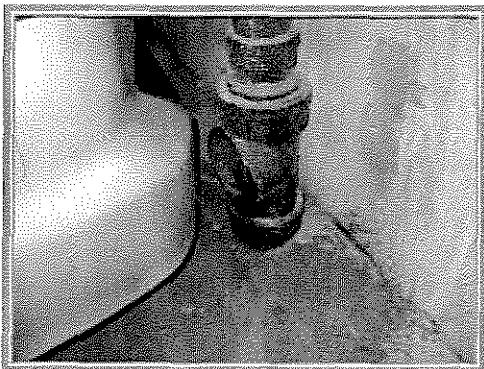
ME2 – Cleanout Cover: A cleanout cover at Level 1 was noted missing. Water was pouring out onto the adjacent concrete surface. This condition can create a slip hazard during the winter when the water freezes.

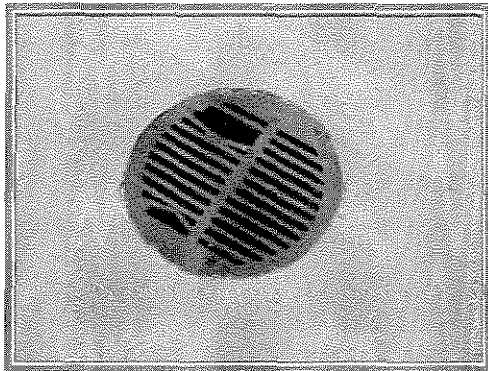
ME4 – Damaged Floor Drain Grate: A new floor drain grate at the new Level 8 has damaged ribs in the grate. This condition creates a trip hazard and should be corrected by installing a new grate.

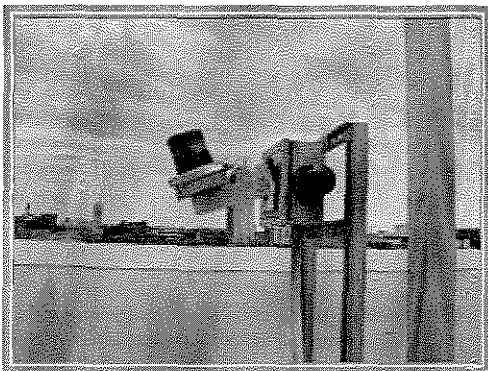
E1 – Emergency Call Box Light: The light fixture at an emergency call box located at the Roof Level has been bent. This allows moisture to enter the fixture.

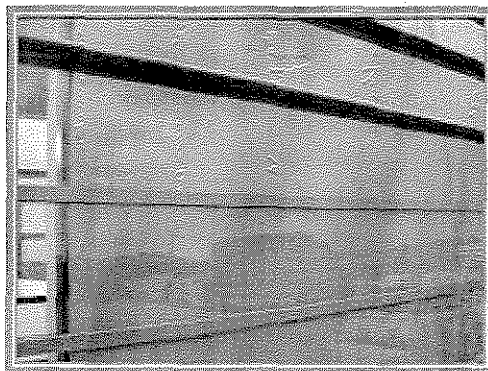
M1 – Leaking Stair Tower: During the review of the northeast stair tower, water staining of the backup panels to the glass were noted. It is believed that this staining was not present after the original construction. Possible areas of water entry could be at the glass glazing & joints and at the roof. All of these items should be covered by the warranty by the installing contractor. We recommend contacting the responsible contractor to evaluate and make any necessary repairs.
