415 West Washington Historic Structure Assessment

415 West Washington, Ann Arbor, MI 48103

Final Report August 29, 2013

RUETER ASSOCIATES
ARCHITECTS

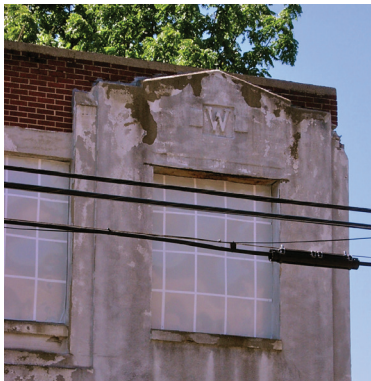
West facade: Art deco parapet with the block "W."

The facade is divided into multiple bays with concrete columns approximately 10 feet on center. The original one-story garage had 12 bays. The 1925 remodeling replaced two of those bays with one large central overhead door. The second floor was being built at this time along with the two story west (right) four bays. The construction joints can be seen here and cracks are evident at this location.

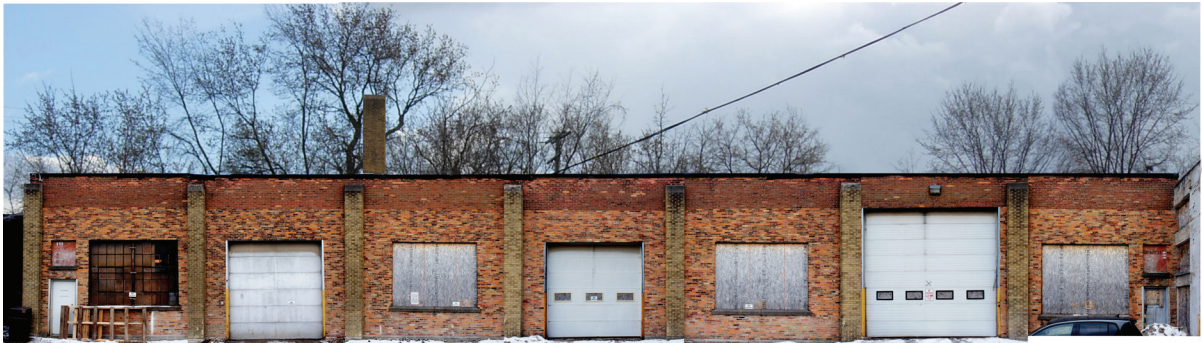
1933-34 Federal Civil Works Administration (CWA) funded building (2013 composite panorama).

The walls are in reasonably good condition, however, some brick faces have spalled off quite badly in certain courses on the south sides and locations near the ground. The brick on the rear south wall which was out of sight is extremely crudely laid, perhaps by the unskilled laborers practicing. The walls are capped with a cast concrete coping which has been covered with roofing materials in an attempt to waterproof the parapets. This may have been done to prevent water from entering the walls and further deteriorating the brick.

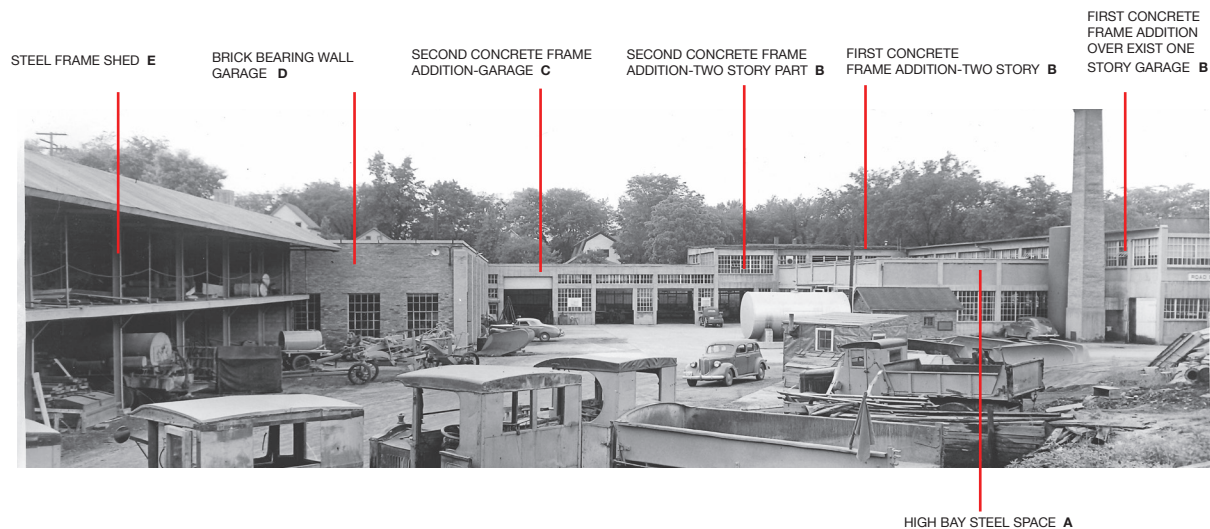
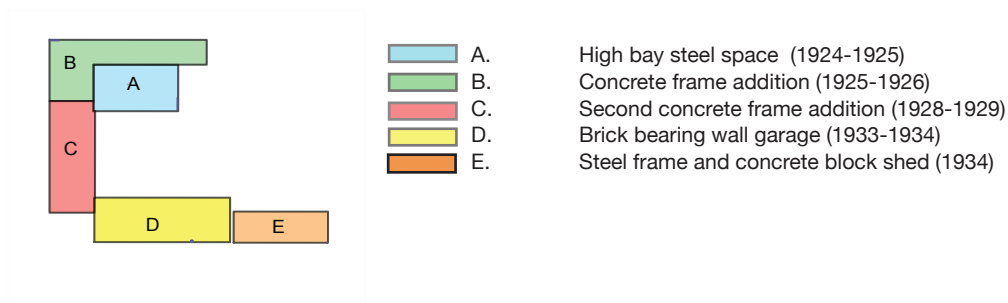
Below is a key plan that represents the different building areas and the dates they were constructed. Adjacent to the key plan are listed the five different areas of investigation.

The investigation was conducted by on site research and the use of historic photographs of the original construction. Washtenaw County Road Commission records dating from 1924 were also used. No destructive investigations such as coring or drilling were done. Some building components such as below-grade foundations or parts concealed by finishes were difficult to evaluate. Each section or area of the complex was separately evaluated according to City RFP #833. Those areas of investigation are summarized below. All the buildings in the complex can be seen in the above panorama photograph from the mid 1940's.

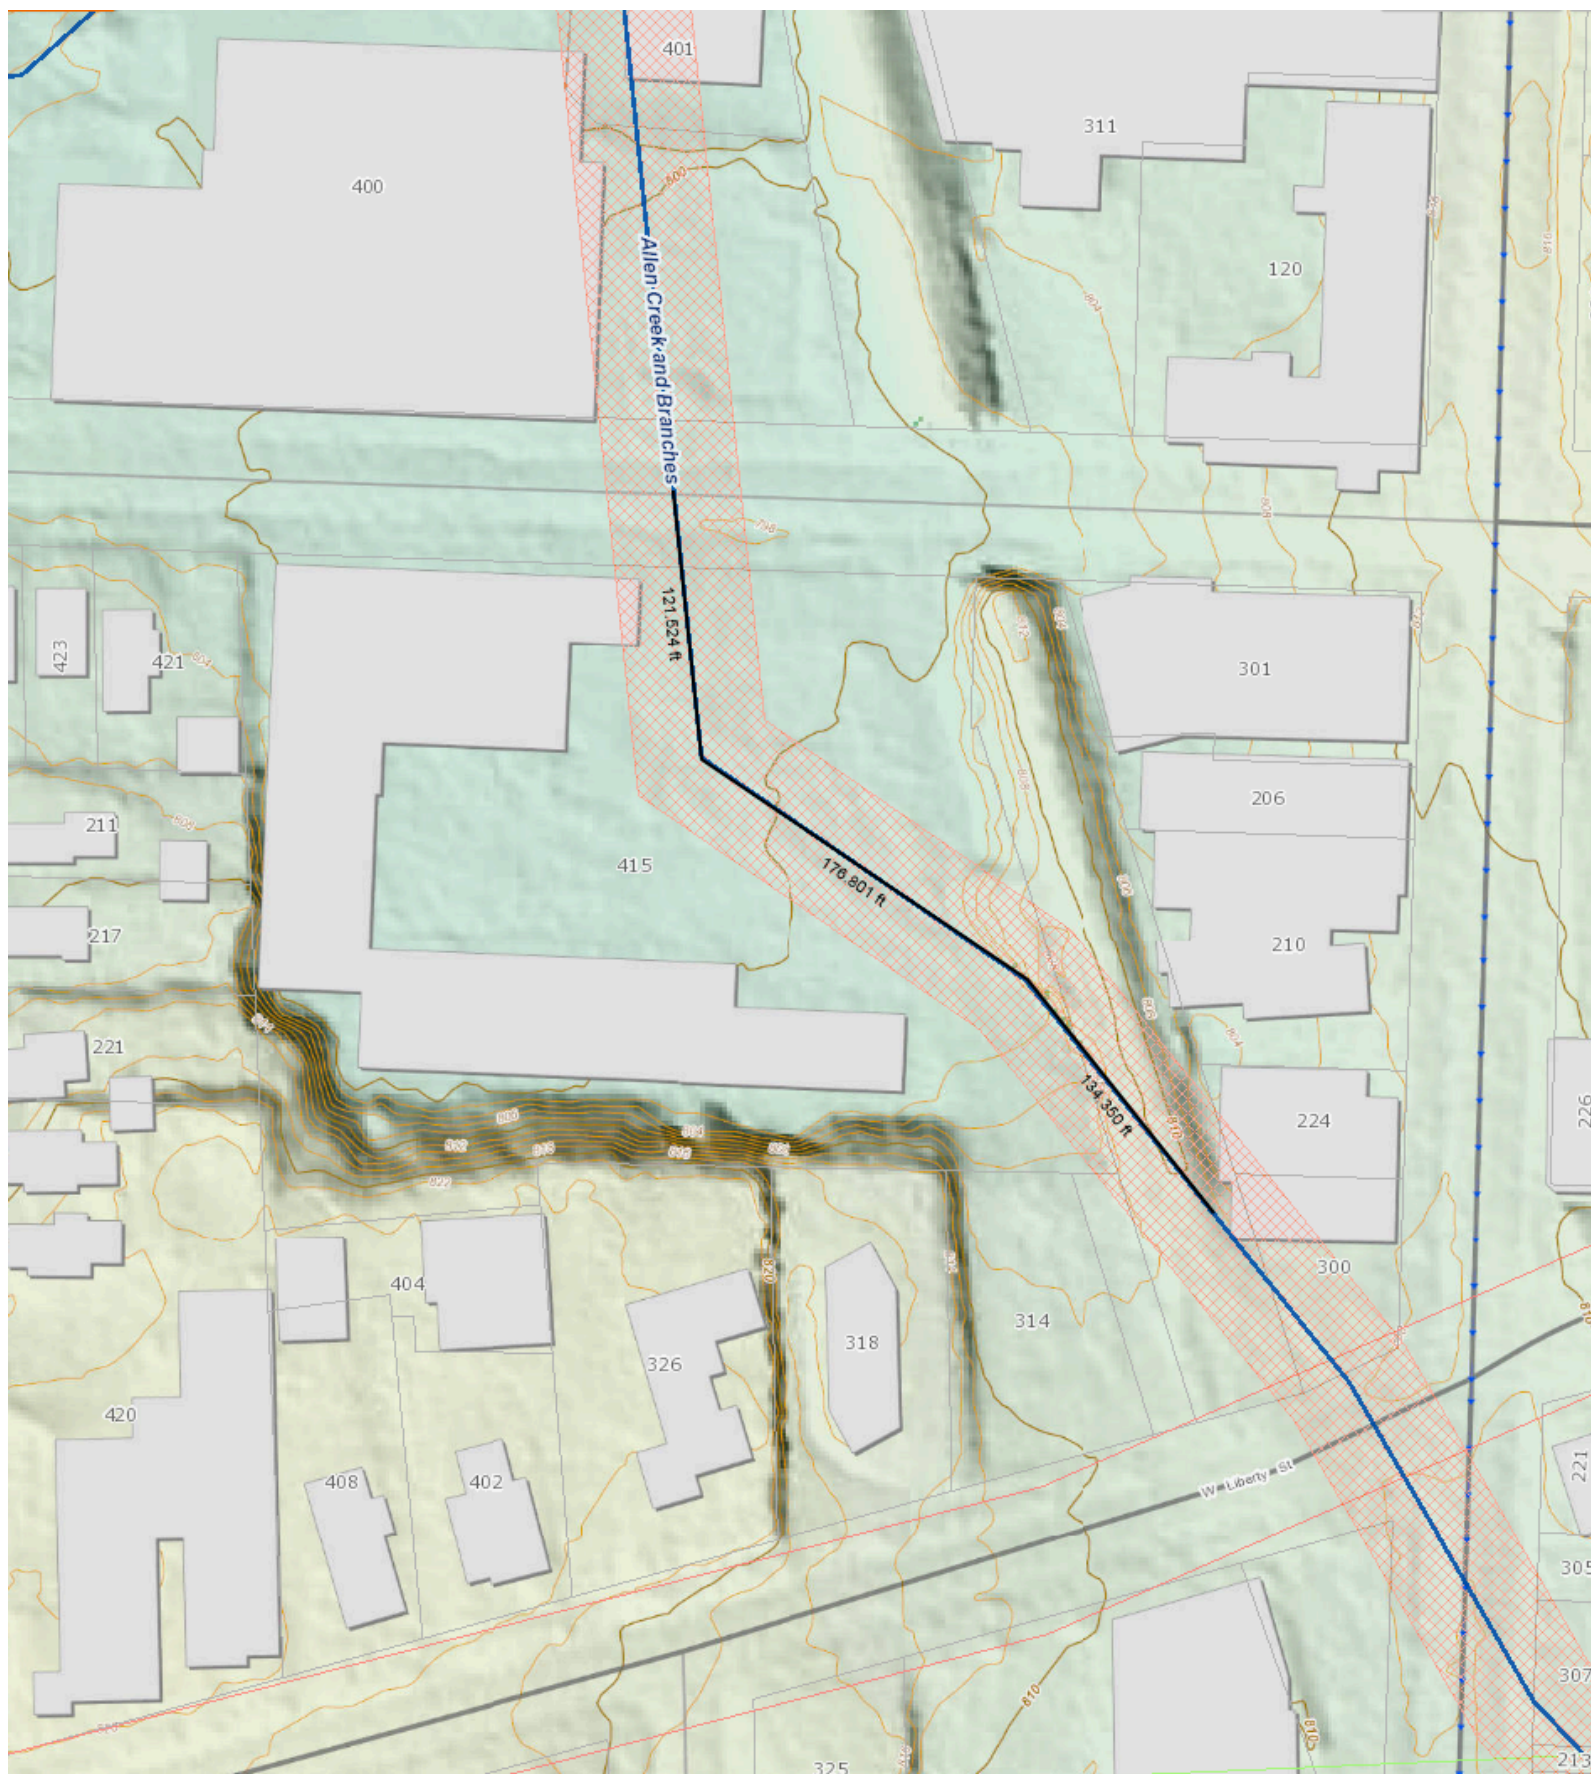
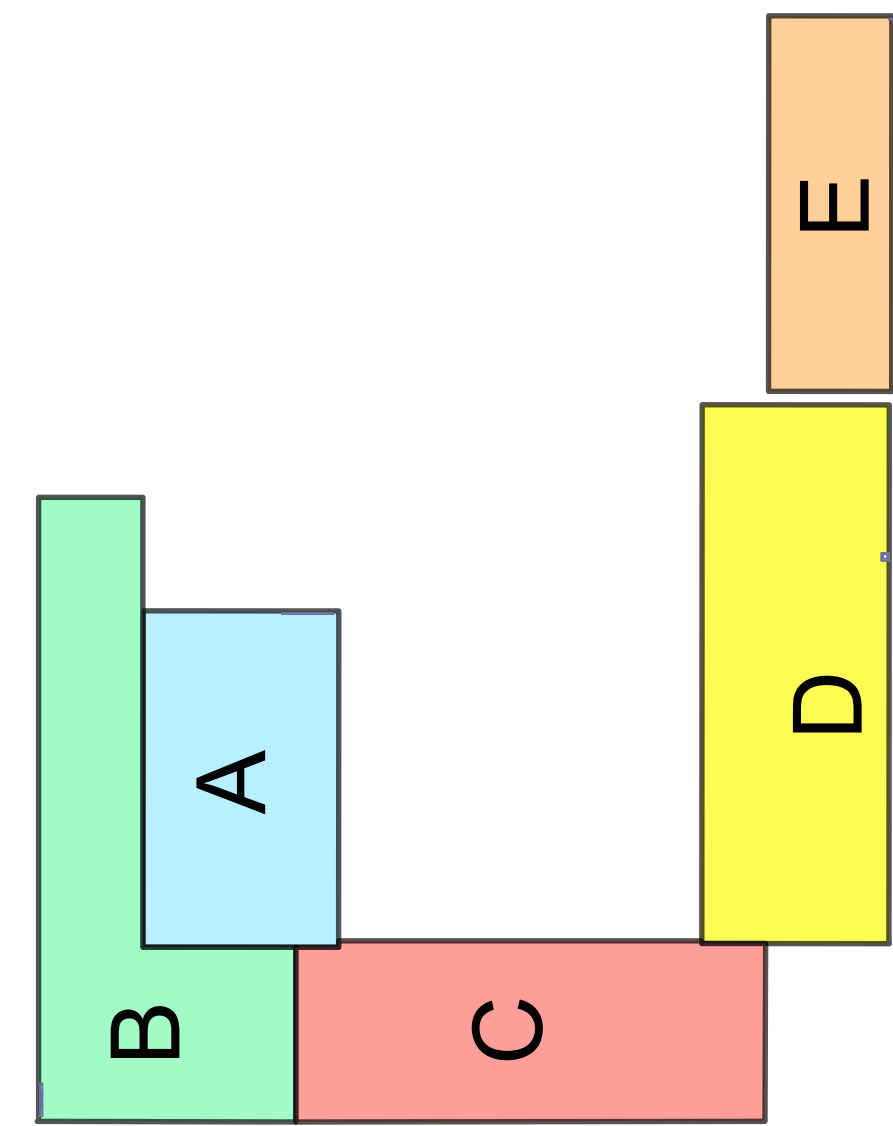
BASE FLOOD ELEVATIONS:

FIN FLOOR ELEV	BASE FLOOD ELEV	WATER ELEV IN BUILDINGS
BUILDING A:	799.0'	804.2'	5.2'
BUILDING B:	799.1'	803.9'	4.8'
BUILDING C:	799.2'	807.0'	7.8'
BUILDING D:	799.4'	808.1	8.7
BUILDING E:	801.0'	808.1'	7.1

The base flood elevations can be read quite accurately for the first segment directly from the simplified building sections which were placed upon the flood profile. Since the second drain segment must be foreshortened for an accurate determination, the cross section at "M" was located on the City's GIS maps and placed on our measured drawings. The orange line therefore represents the corrected base flood elevation projection.

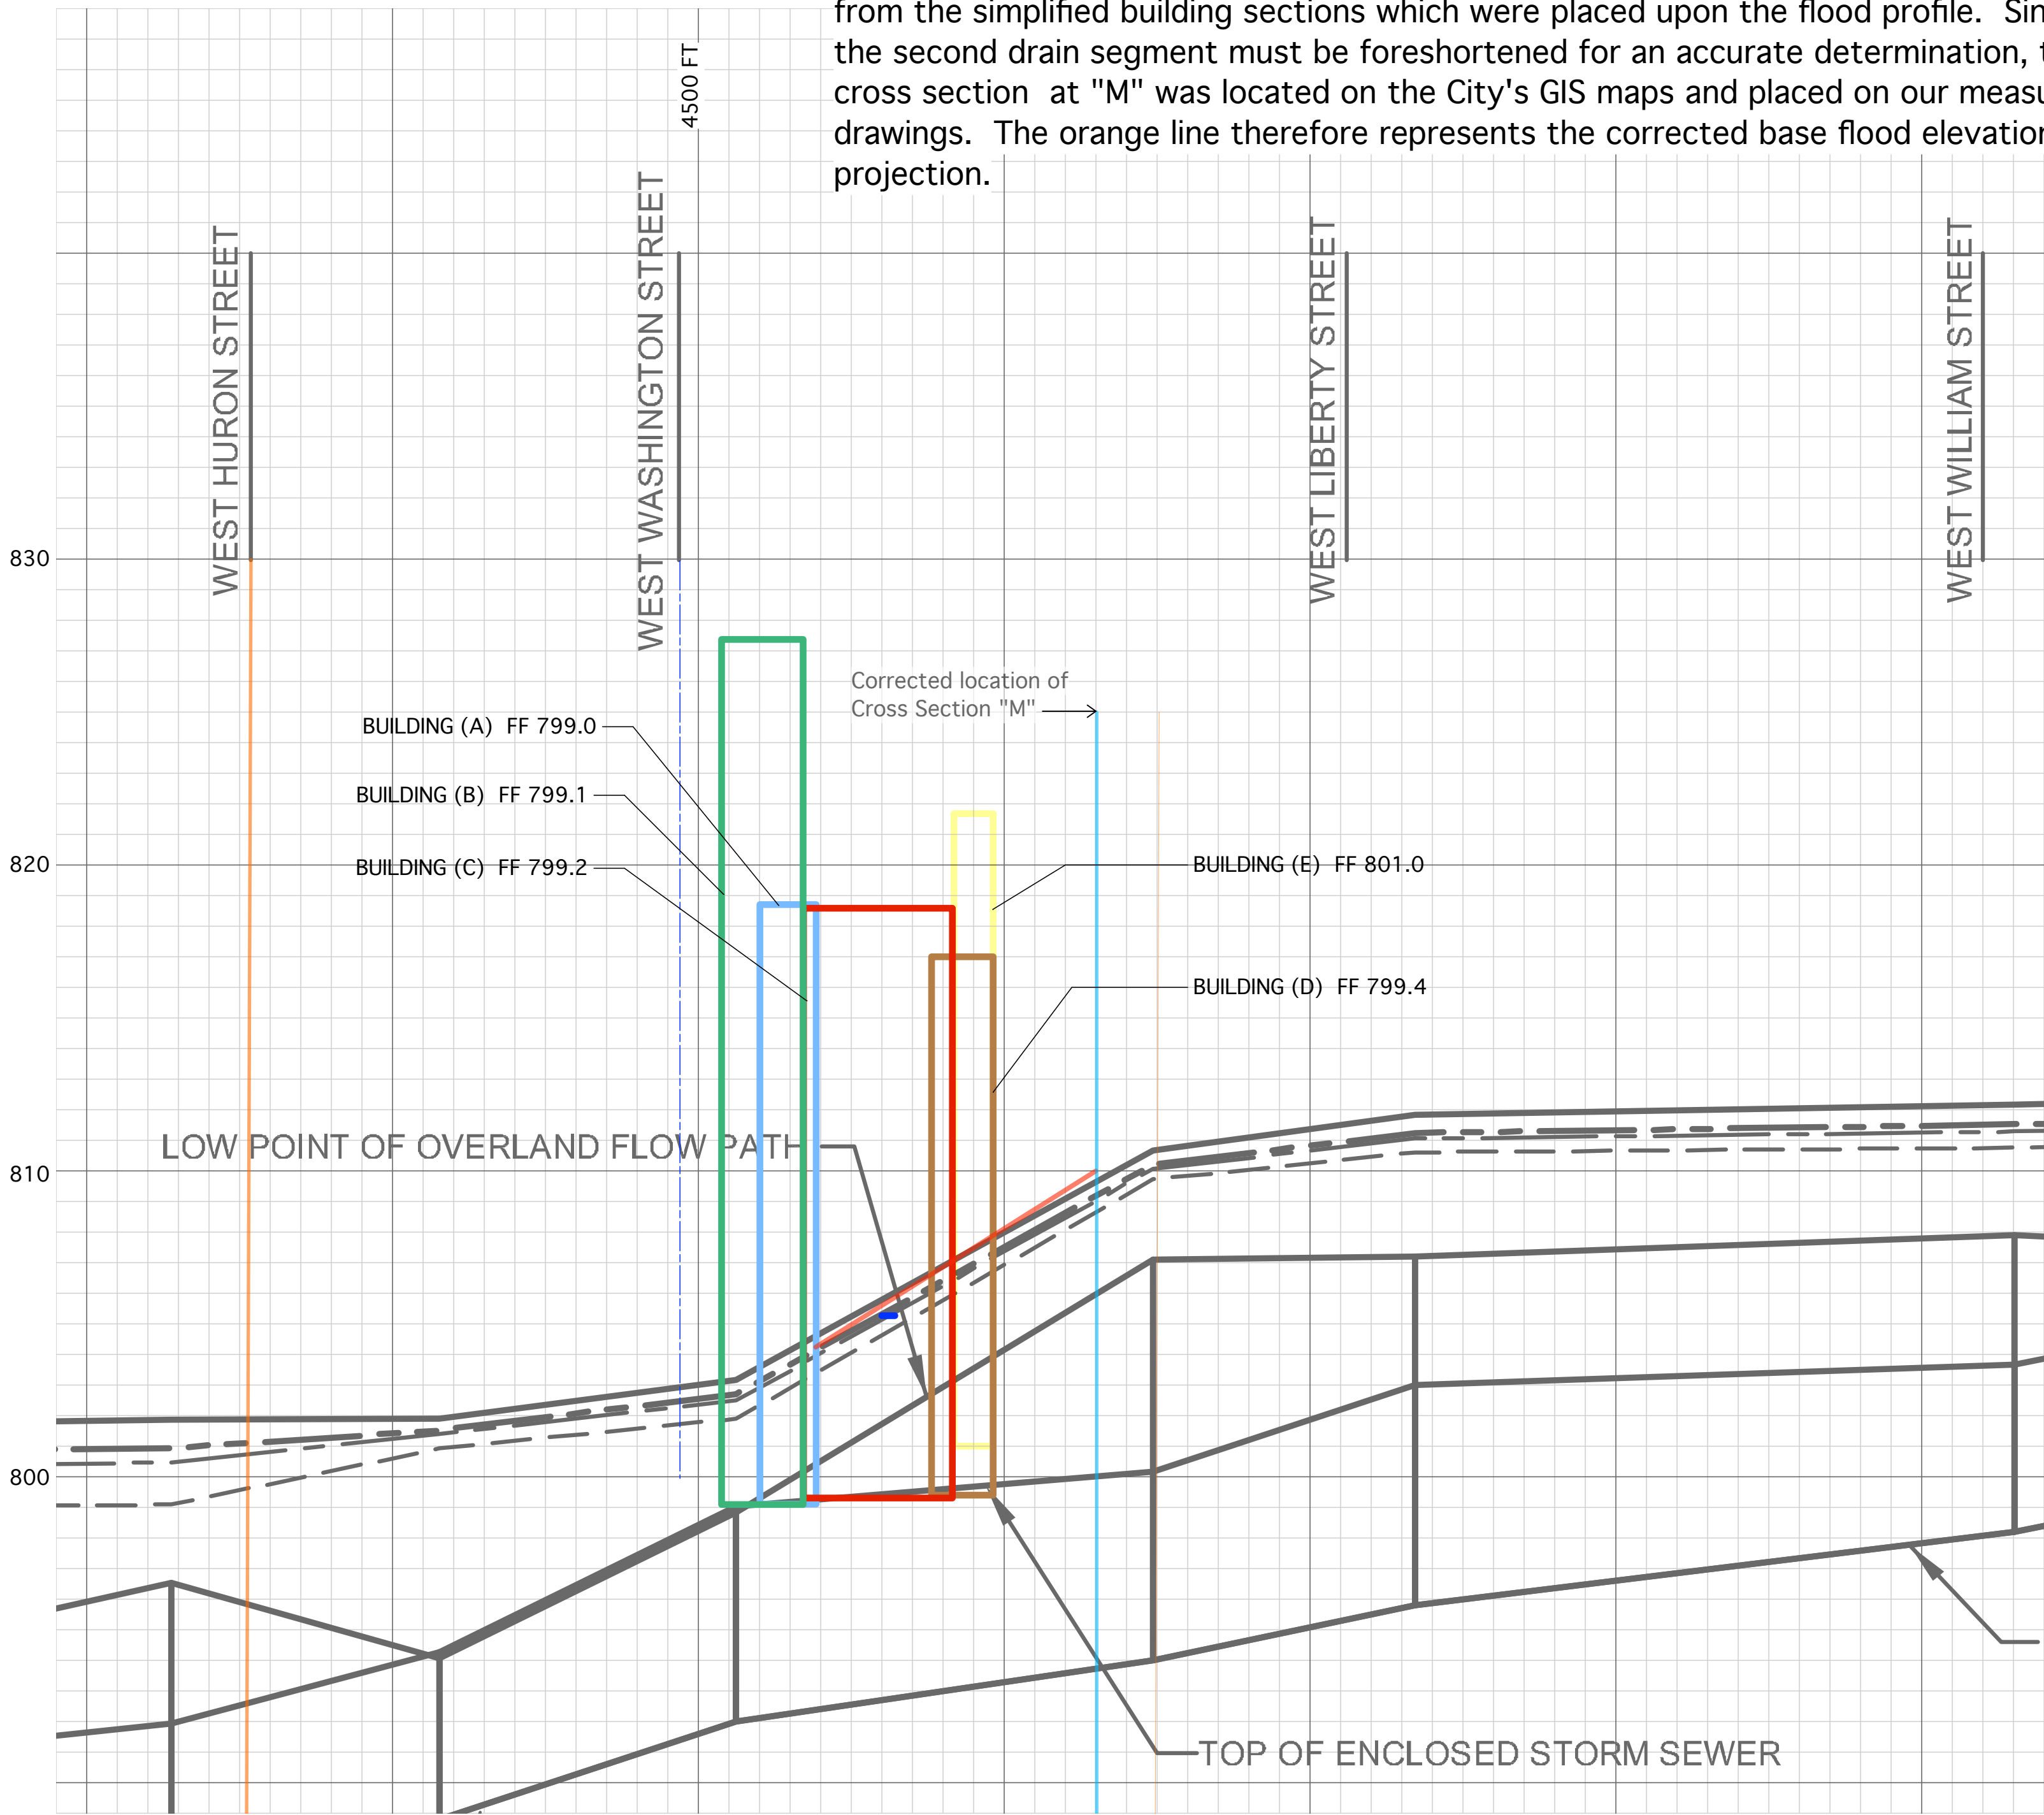
PARTIAL FEMA FLOOD PROFILE OF ALLEN CREEK DRAIN:

CORRECTED 1% FLOOD LINE (ORANGE)

BUILDING (D & E)	808.1
BUILDING (C)	807.0
BUILDING (A)	804.2
BUILDING (B)	803.9
