FOURTH & WASHINGTON PARKING STRUCTURE

MAINTENANCE REVIEW - 2008

Carl Walker, Inc. Project No. R1-2008-246

CITY OF ANN ARBOR DDA

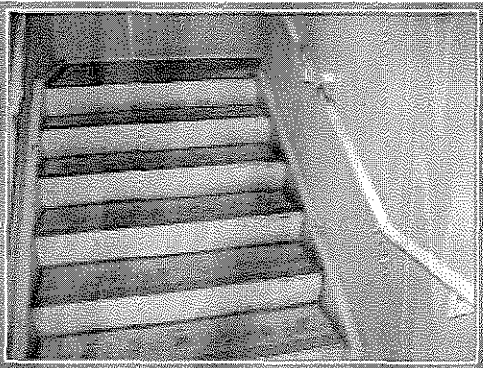
W6 – Deck Coating (at South Stair): Surface corrosion was noted on the steel in the South Stair. The corrosion is minor and has not created significant section loss. However, if no protective action is taken, the corrosion will become more severe and will eventually result in costly repairs. We recommend cleaning the steel to remove corrosion and deck coating the treads, risers and landings at the South Stair to protect the steel from further corrosion.

M1 – Clean & Paint Steel (at South Stair): As stated in Item W6, corrosion was noted on the steel in the South Stair. Corrosion was also noted on the handrails in the South Stair. In addition to deck coating the South Stair, as recommended in Item W6, we recommend cleaning the steel to remove corrosion and repainting the underside to protect against further corrosion. The handrails should also be repainted.

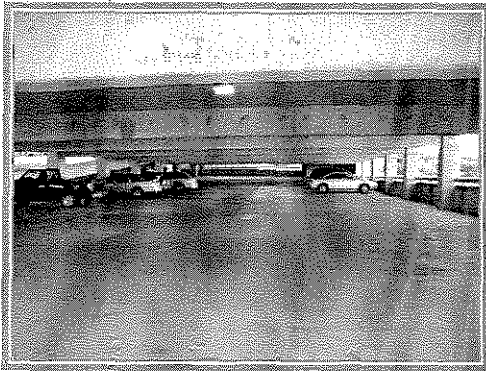
C1 – Top of Slab Delaminations: Throughout the structure, there are areas of the concrete floor slab that are delaminated. These delaminations typically occur in the slab above cast-in-place concrete beams where the embedded reinforcing steel is at the highest point in the slab, and the most vulnerable. The total area of deterioration is less than 300 square feet. Some additional deterioration can be expected from chloride contaminated concrete even though protected by deck coating. These areas should be repaired followed by reapplication of the deck coating at these repair areas.

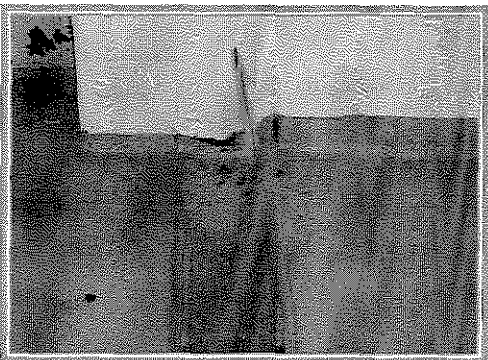
W8 – Expansion Joint – Ribbon Seal: In 1998 the expansion joints between the parking structure and the main stair/elevator tower were replaced. Portions of the urethane nosing on these expansion joints have failed and lost bond to the concrete. In addition to nosing failures, one location was noted where the gland itself was damaged. These items should be repaired to prevent water and chloride damage to the structure below. These items may also become possible trip hazards in these high pedestrian traffic areas if not repaired.

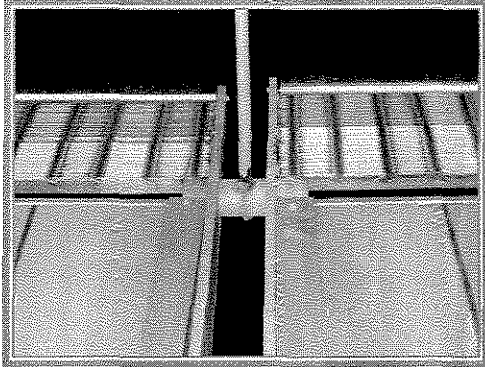
M1 – Repair Canopy Connections: Corrosion of the welded connections were noted at the canopies over the entry/exit lanes. Continued deterioration to these welds may lead to failure of the canopy supports. These areas should be cleaned and re-galvanized.

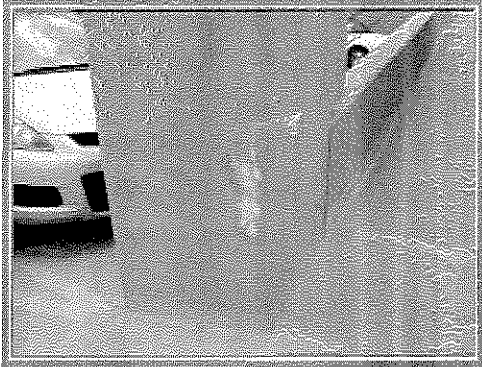
C4 – Column Delaminations: There were several locations in the structure where column or shear wall corrosion related concrete deterioration has occurred. These areas should be repaired with conventional concrete patching techniques.

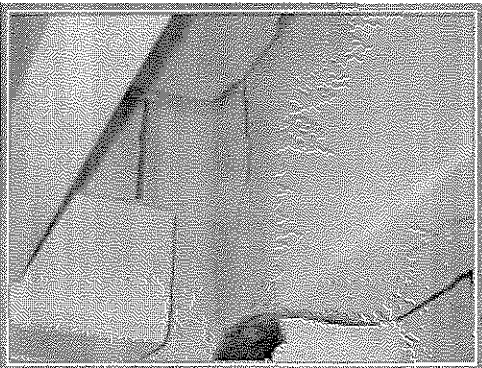
C6 – Beam Delaminations: There were a few locations with corrosion induced concrete deterioration. Delaminations at or near the bearing areas should be considered a priority repair and can be repaired with conventional patching techniques.

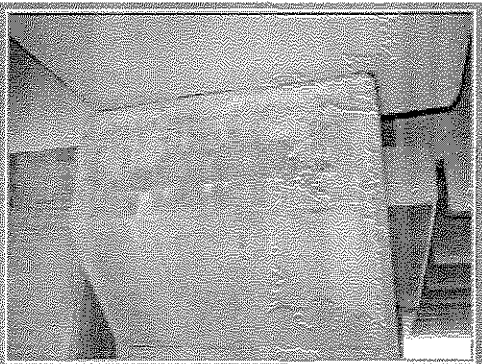
C7 – Haunch Delaminations: Throughout the structure there is continued deterioration of concrete haunches that supports the inverted tee beams. Delaminations at or near the bearing areas should be considered a priority repair and can be repaired with conventional patching techniques.

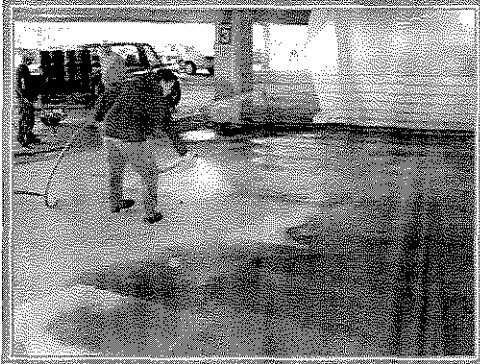
W7 – Sealer: In 1998 a 100% silane sealer was applied to all supported concrete areas that were not deck coated. Silane sealers help to reduce water and chloride intrusion into the concrete that may lead to embedded reinforcing steel and embedded connector plate steel over time. By 2009 this sealer will have been in service for 11 years and it is anticipated that its effectiveness in reducing water and chloride infiltration will be significantly diminished due to wear and abrasion. It is recommended that a 100% silane sealer be installed.

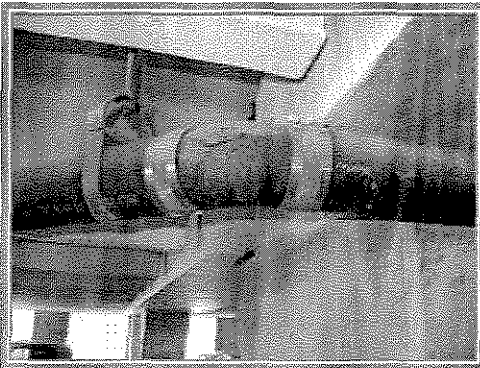
ME1 – Broken Storm Piping: Storm piping appears to be in good condition throughout the parking structure. Only one broken pipe was noted at Level 2. Storm piping should be flushed on a yearly basis during wash downs. This keeps sediment from building up in the piping, which can lead to blocked, frozen and broken pipes.

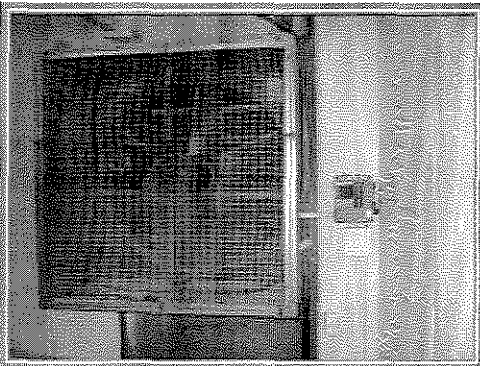
ME2 – Ventilation Fan: Existing mechanical ventilation fans are in disrepair and not functional during our review. Carbon monoxide is a poisonous gas that can build up rapidly at the lower (enclosed, underground) levels of a parking garage. It is required by code that an enclosed structure (such as the lower levels A & B) must have fans that operate continuously or operate by a gas monitoring system. Repair of these fans should be considered a priority.

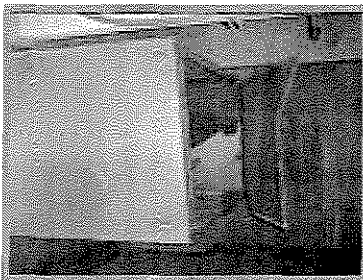
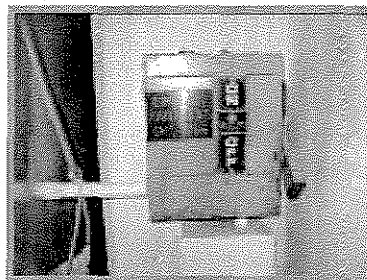
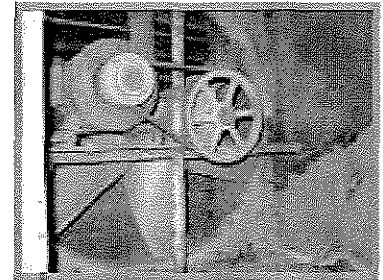
ME3 – CO2 System: The existing carbon monoxide detection system does not appear to be functioning at this time. There is only one unit located at the lowest area of Level B. This unit should be updated with a newer system and integrated with the existing fan system. Newer systems allow remote monitoring of the system via a computer and software.

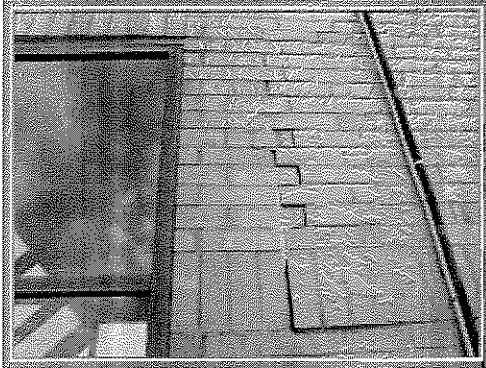
M3 – Masonry Tuckpointing: Some mortar joints in the masonry facade on the east stair were noted to have failed and are a point of water infiltration. Tuck pointing and mortar repair is recommended at these locations.

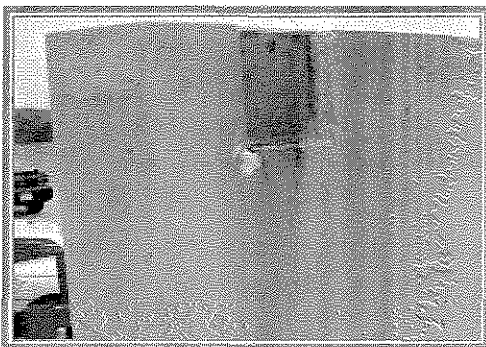
M5 – Steel Connector Plates: Some of the exposed steel plate connectors are experiencing some minor corrosion. Surface preparation and painting repair is recommended at these areas.

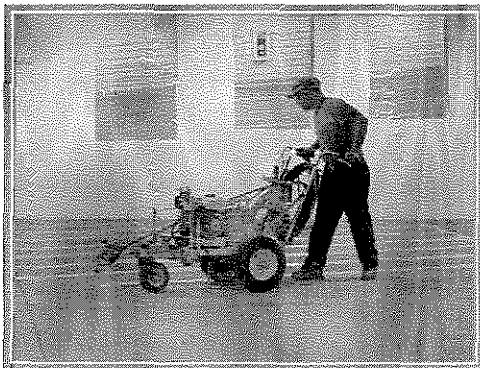
M8 – Pavement Markings: After the sealer reapplication and the recoating of the deck coating at the Roof Level it is recommended to restripe the entire parking structure.

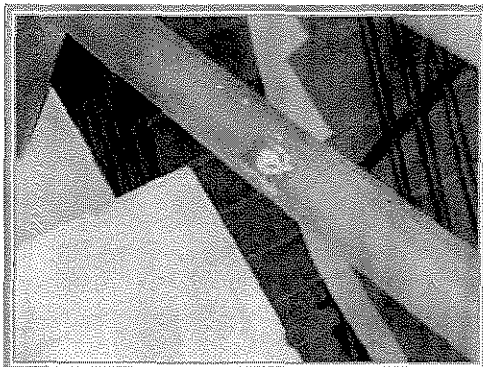
M9 – Handrails: Handrails in all three stair towers were noted to have spots that require touchup of the painting system. Rust was also noted at the vertical supports where they enter the concrete step. These locations should be prepped, cleaned and repainted as needed.

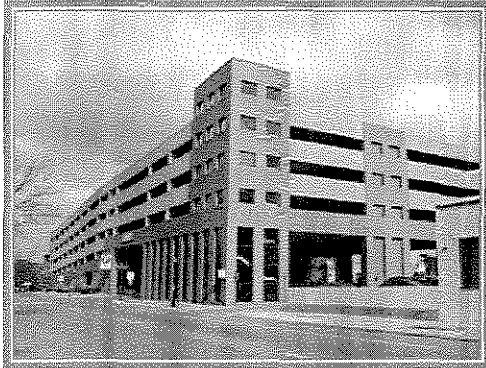
O1 – Restaining Precast Facade: The precast facade on this structure was stained during the original construction in 1986. The color of the facade has faded considerably. This item would include staining all of the precast elements on this structure to brighten up the exterior. It is believed that these concrete elements were stained and that pigmented cement was not used. It may also be possible to seal these areas to bring out the color of the existing better.

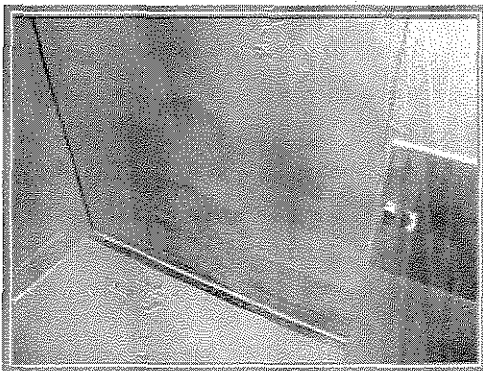
M3 – Painting: Paint in this structure is in very good condition. A few areas were noted to need some touch up to maintain the condition of the paint system.

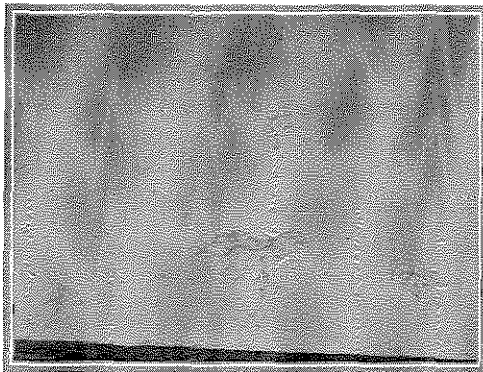
C1 – Top of Slab Delaminations: There are areas of the concrete floor slab that are delaminated due to corrosion of embedded reinforcing steel. Some additional deterioration can be expected from chloride contaminated concrete even though protected by a deck coating membrane. These areas should be repaired followed by reapplication of the deck coating at these repair areas. The majority of the deterioration noted in the top of slab is located at Levels 7 & 8, where the concrete overlay installed in 1992 has debonded. These areas are slowly growing in size and although repairs are not required at this time, the slabs should be reviewed on a regular basis.

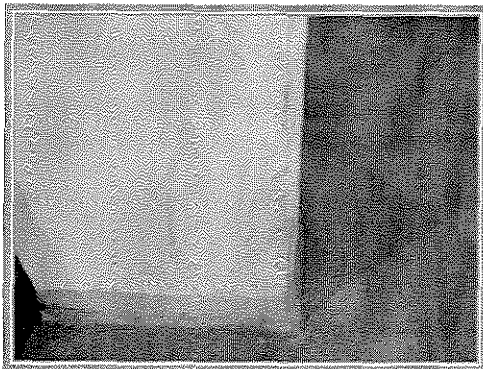
C2 – Underside of Slab – Ceiling: At various locations throughout the parking structure there is corrosion related concrete deterioration of the underside of the floor slab. The total quantity is less than 50 square feet. This minor amount of deterioration is not unexpected from ongoing corrosion activity.

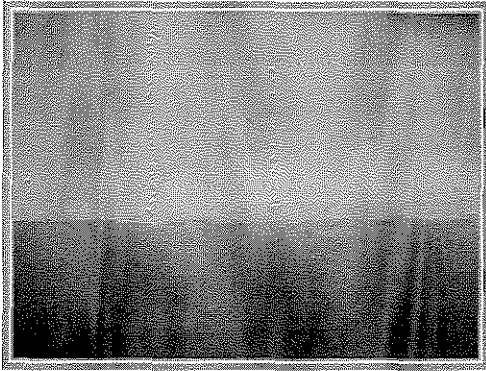
C3 – Column Delaminations: There are some limited corrosion induced deterioration of the concrete columns in this structure. The deterioration is a result of ongoing corrosion, particularly of column areas near the floor surface that are exposed to splash effect of chloride laden water on the floor surface.

C4 – Wall Delaminations: There are some limited corrosion induced deterioration of the concrete walls in this structure. The deterioration is a result of ongoing corrosion.

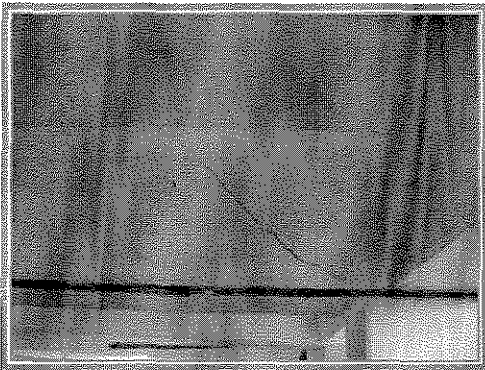
C5 – Beam Delaminations: There is some corrosion induced deterioration of the concrete beams in this structure. The deterioration is a result of ongoing corrosion.

C6 – Curb Delaminations: There is approximately 5 square feet of curb delaminations located at Level 4.

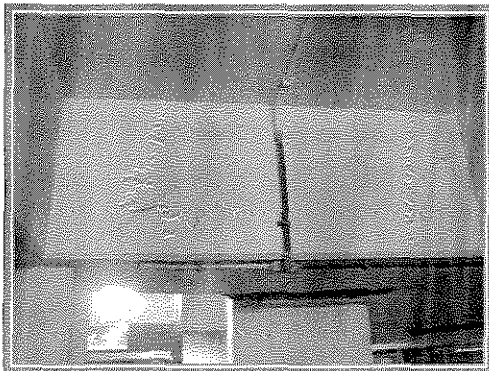
W3 – Rout & Seal Cracks: Some random cracks in the topping, walls and columns at the Roof Level were noted. A few cracks were sealed during recent repair, but more exist and should be sealed to prevent water infiltration.

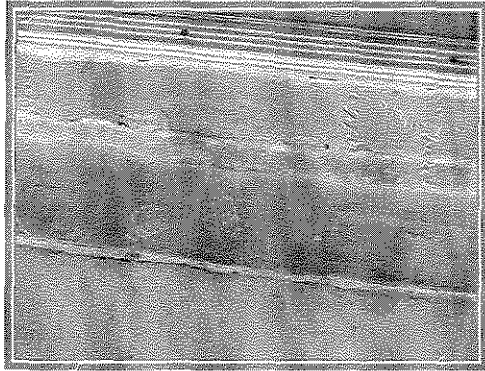
W4 –Expansion Joint –Ribbon Seal: There are a couple of areas located at the stair towers (at Levels 7 & 8) where failure of the urethane nosing material on the urethane ribbon seal has occurred. These areas need to be repaired to prevent water infiltration and deterioration of underlying concrete.

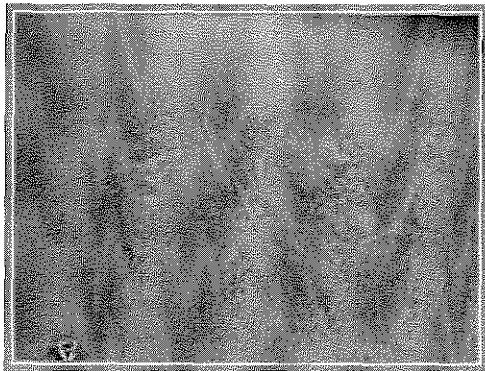
W5 – Deck Coating: Several areas of deck coating throughout the parking structure are beginning to wear. A majority of these areas are in high traffic or turning areas. These areas should be repaired and top coated. The speed ramp down from the far east end of the structure has experienced some wear and should be re-coated.
